Pinetop-Lakeside Aquatic Wildlife Enhancement Project

**Arizona Water Protection Fund Grant Application – FY 2019
Arizona Game and Fish Department; Pinetop Regional Office**

A Class III Archaeological Survey of the Arizona Game and Fish Department Pinetop Region Headquarters in Pinetop-Lakeside, Navajo County, Arizona

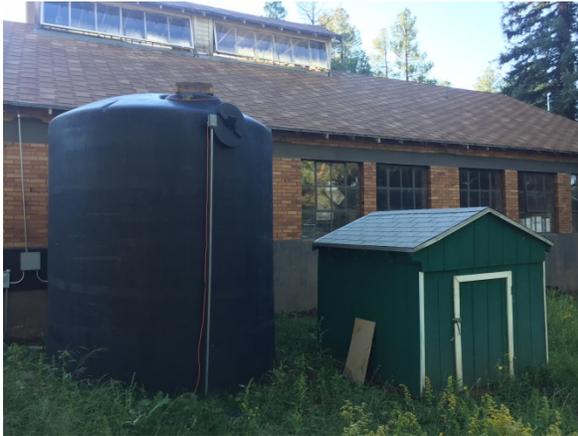
Photo 1: Existing Well House & Storage Tank

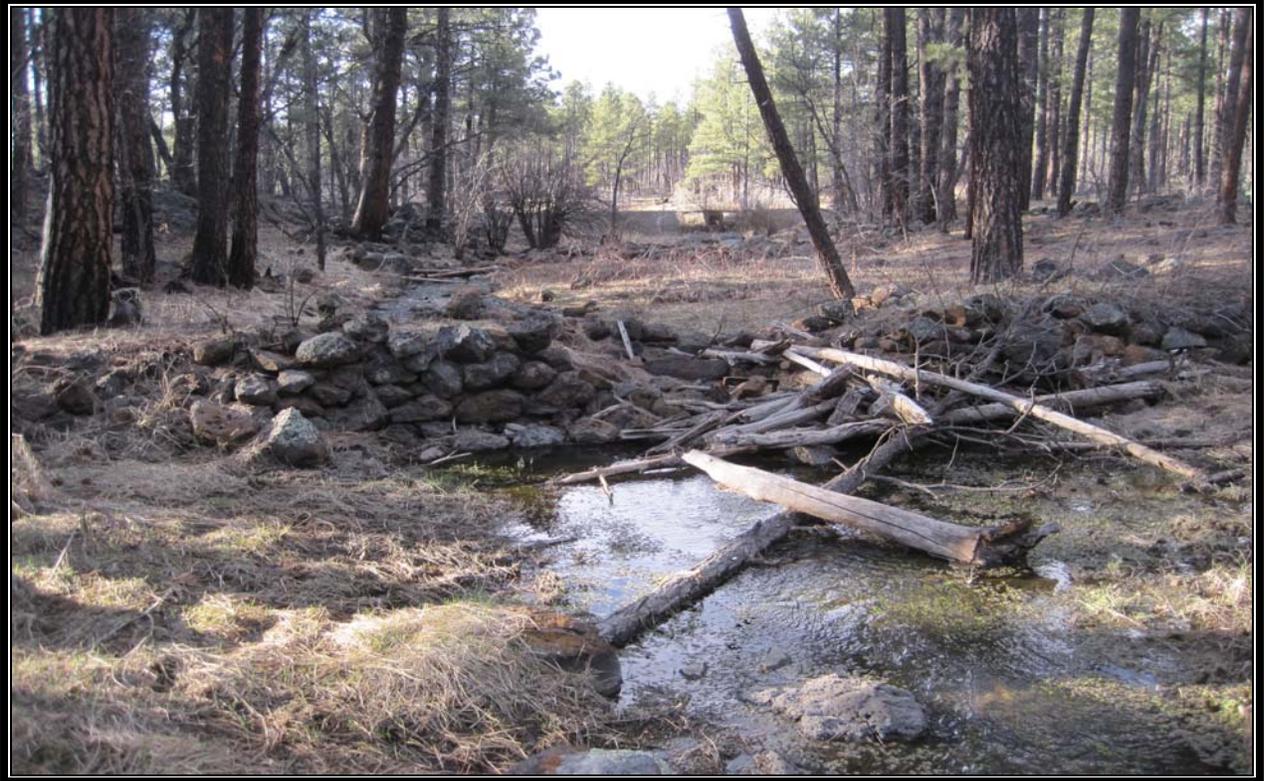
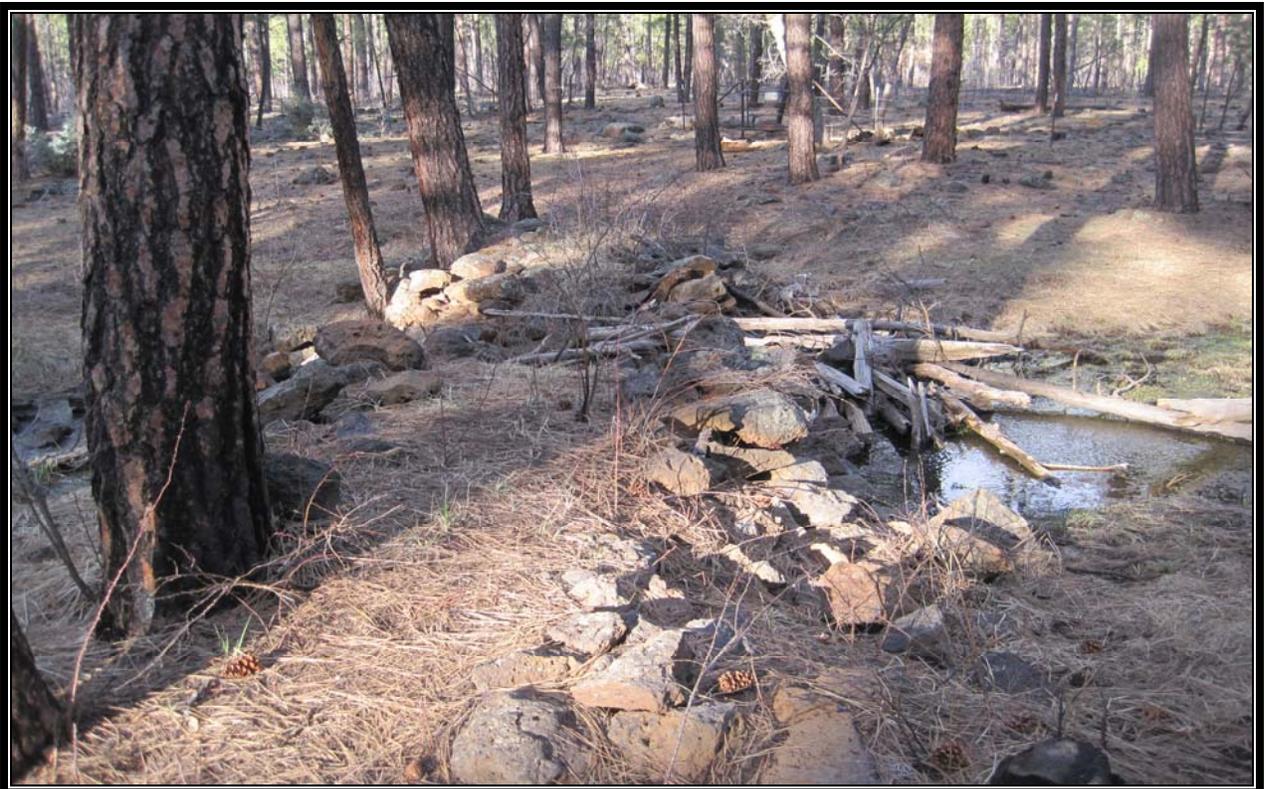
Figure 6. AZ Q:13:27 (ASM), Feature 1, looking upstream (northwest).

Figure 7. AZ Q:13:27 (ASM), Feature 1, looking northeast.

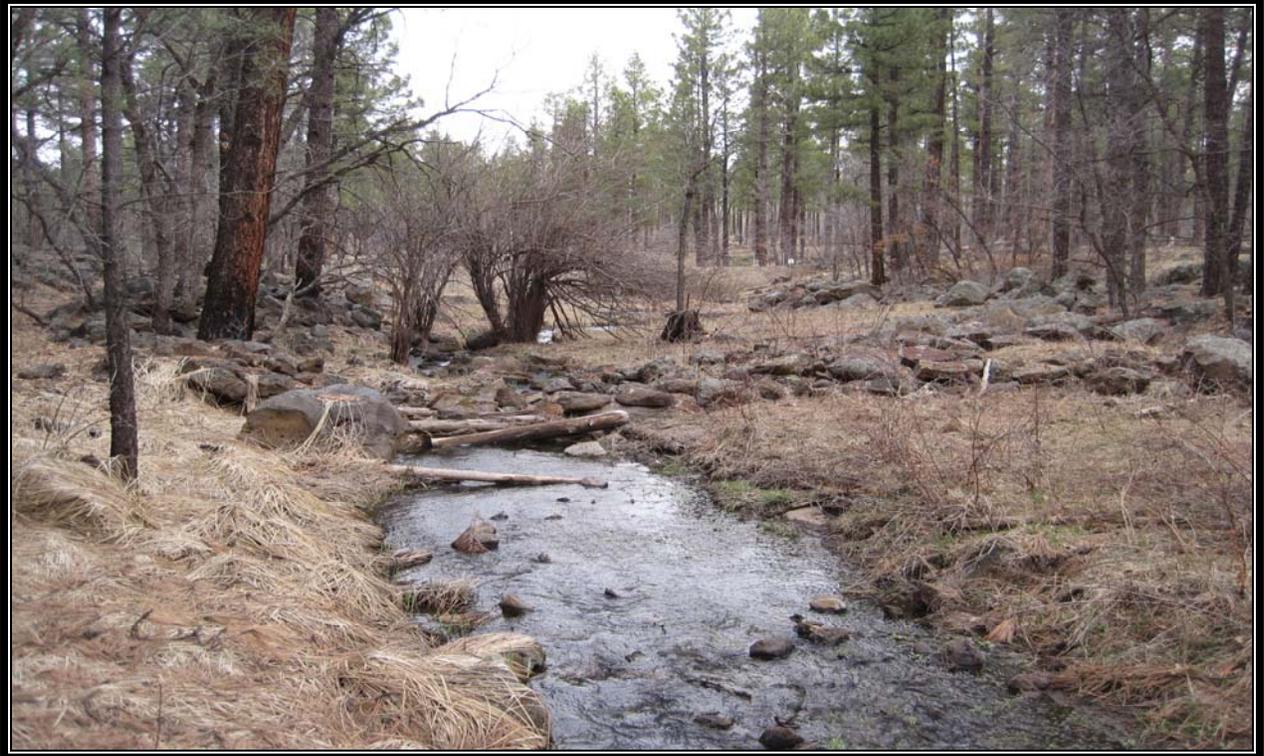
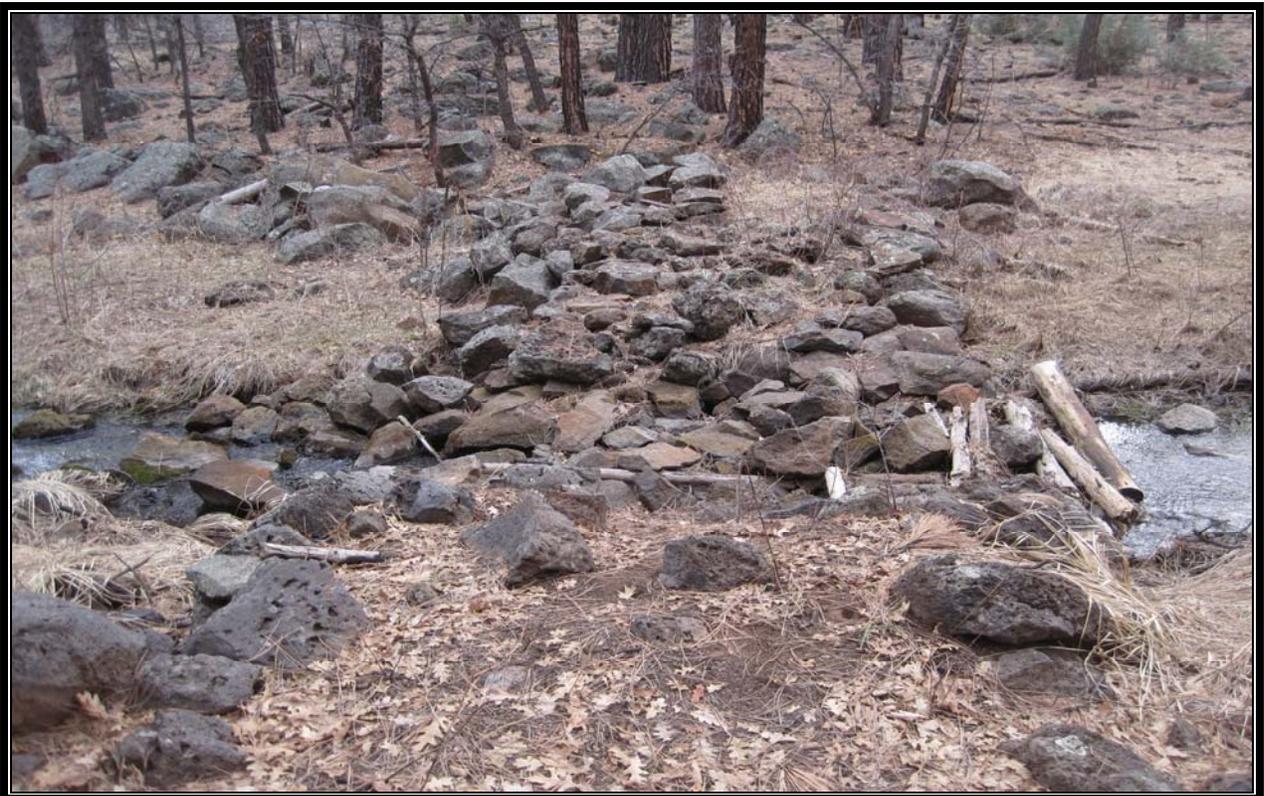
Feature 2: Feature 2 is a rock dam/water control feature located approximately 55 ft. downstream (northwest) of Feature 1 (Figures 8-9). It is oriented northeast-southwest, and is 39 ft. long, 8.5-11 ft. wide, and 1.5-2.0 ft. high. It is in fair to poor condition, with most of the rocks in the center collapsed and the ends relatively intact.

Figure 8. AZ Q:13:27 (ASM), Feature 2, looking upstream (northwest).

Figure 9. AZ Q:13:27 (ASM), Feature 2, looking northeast.

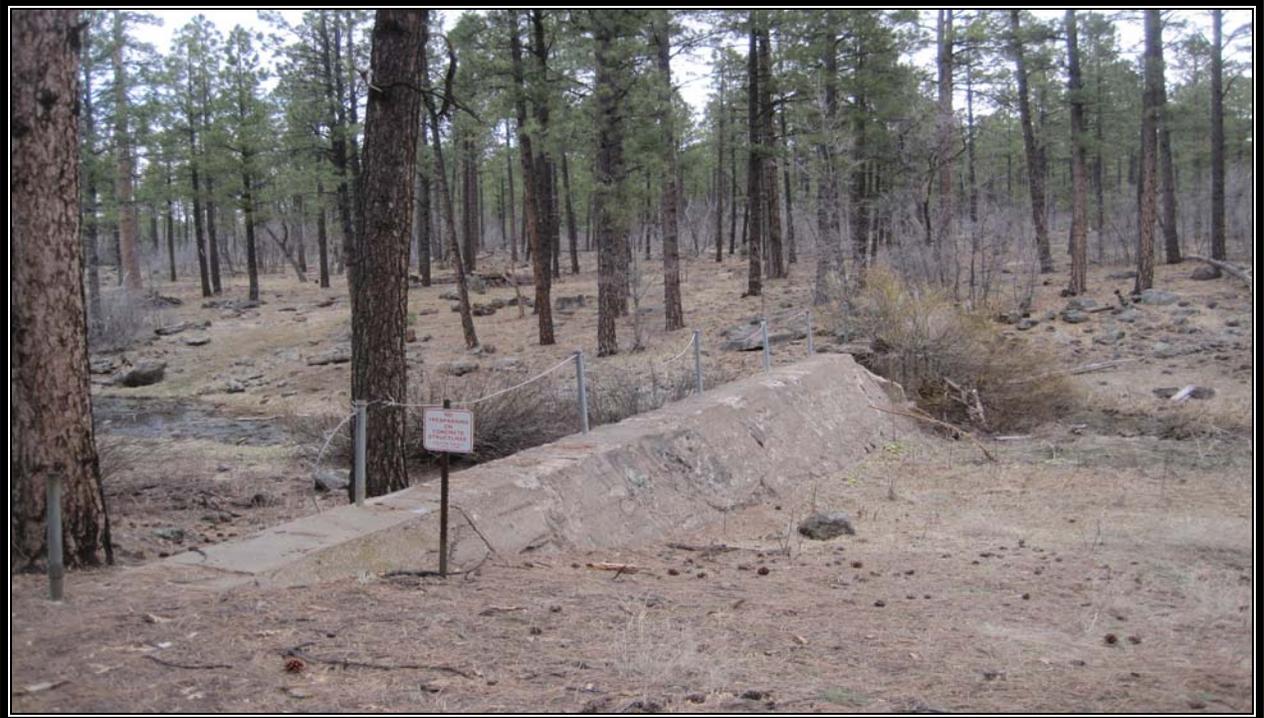
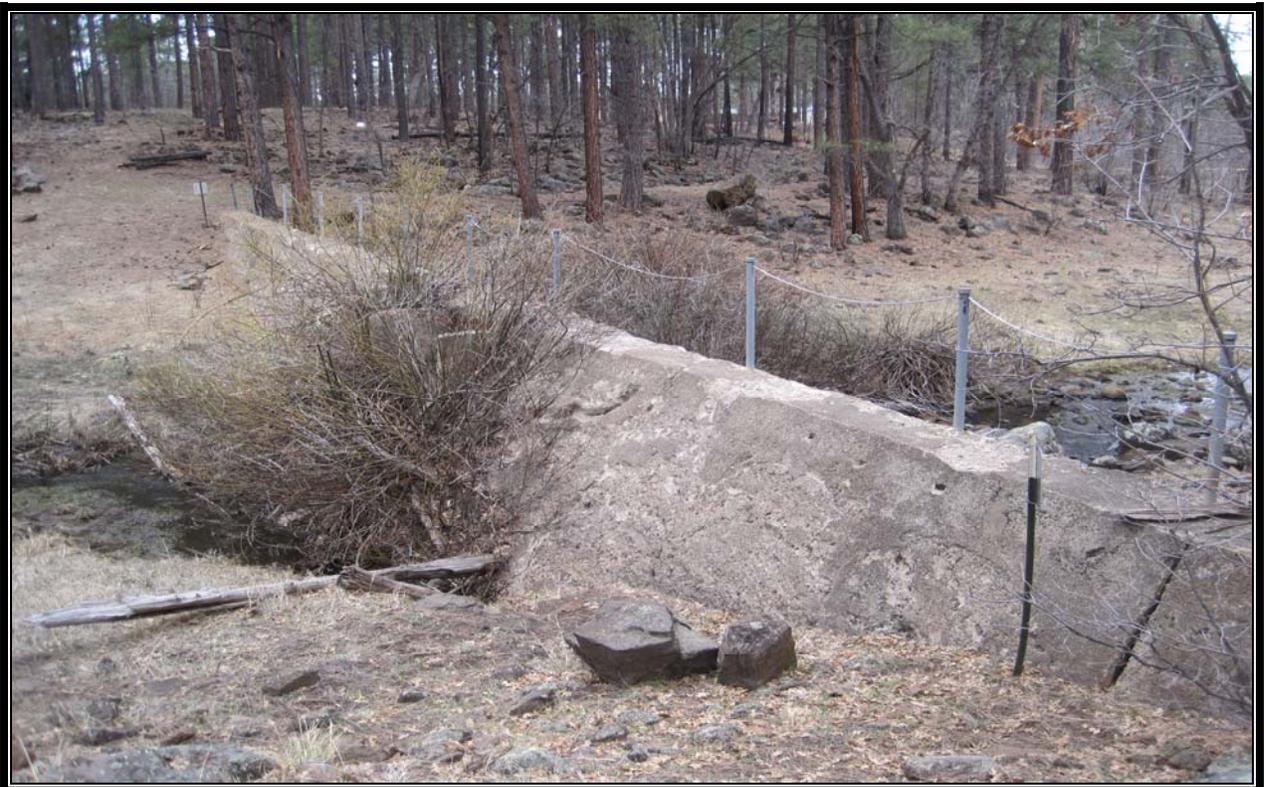
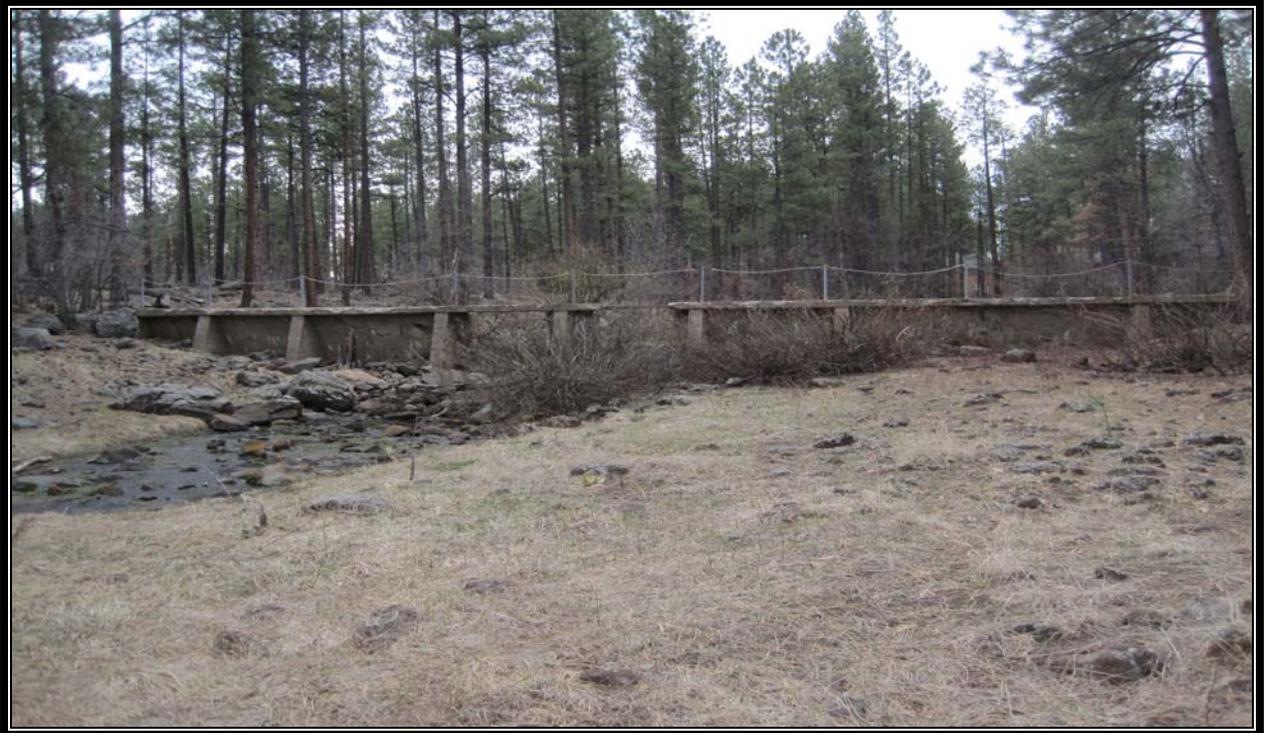
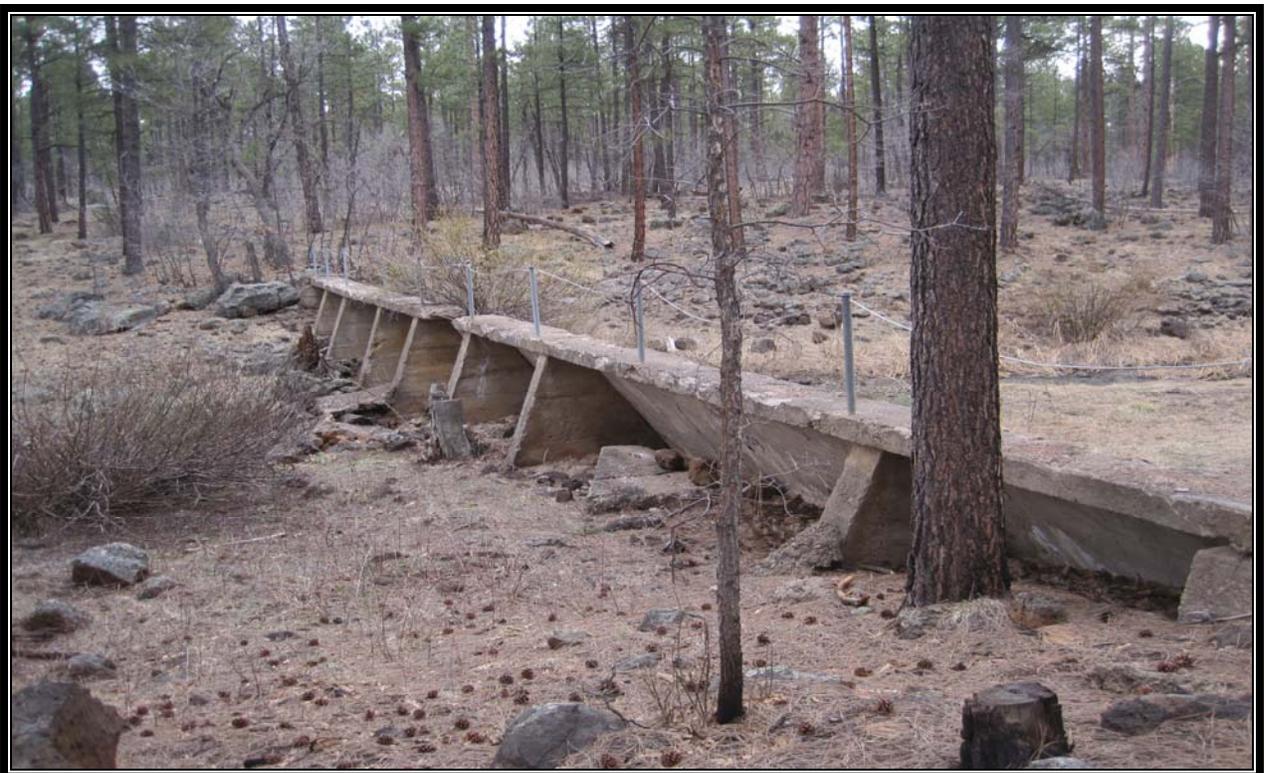
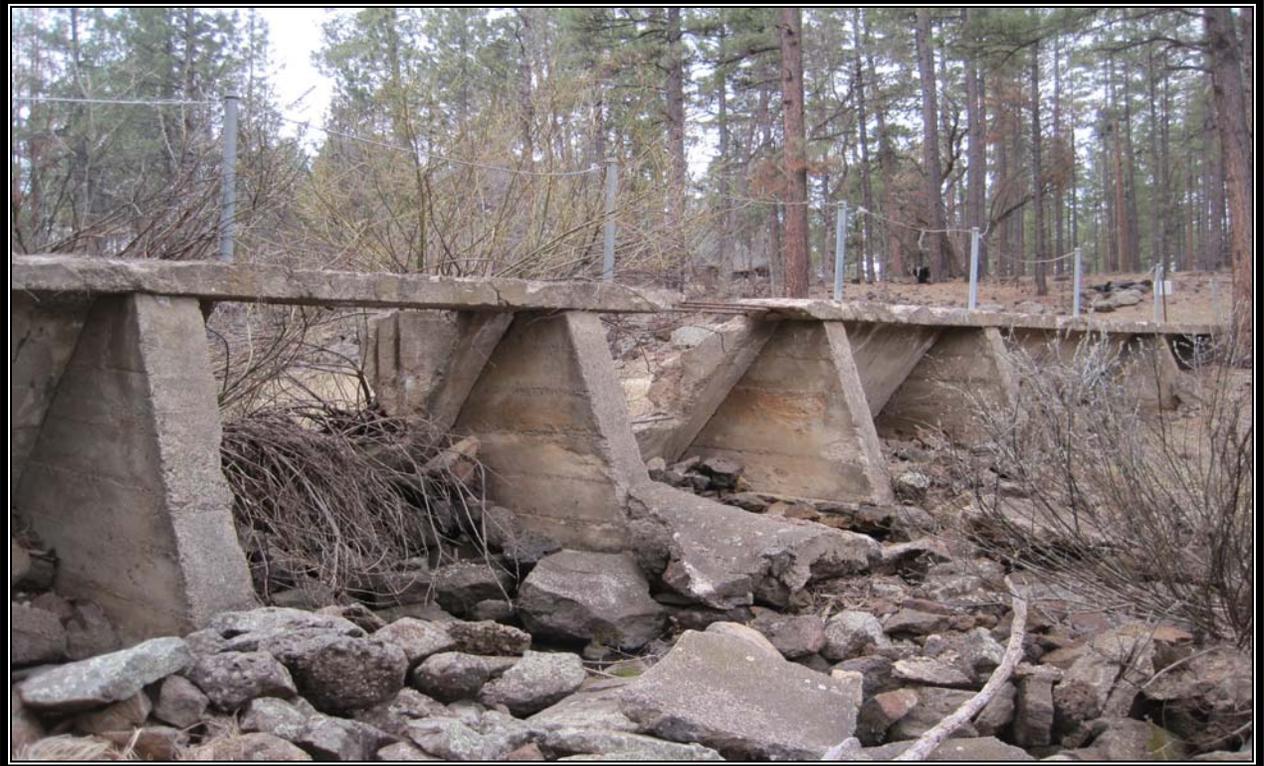
Feature 3: Feature 3 is a poured concrete, buttress dam located near the eastern edge of the APE (Figure 10). Feature 3 is oriented northeast-southwest, perpendicular to Billy Creek, and extends from bank to bank across the creek although it does not impound water due to broken sections within the dam. It has a sloped face on the upstream (southeast) side (Figure 11), with triangular buttresses supporting the sloped face on the downstream (northwest) side (Figure 12). This creates an open or hollow area on the downstream portion of the dam (Figure 13). The dam has a narrow, level surface across the top. It is 103.5 ft. long, and varies in width from 5.0 ft. at the base to 2.0 ft. at the level top surface. The top of the dam is level; however, its height relative to the ground surface ranges from level with the modern ground surface at the southwest end to a maximum of 6.0 ft. above on the upstream side and 8.0 ft. above on the downstream side near the center of the creek channel.

Figure 10. AZ Q:13:27 (ASM), Feature 3, looking north at the upstream (southeast) face of the dam.

Figure 11. AZ Q:13:27 (ASM), Feature 3, looking west at the sloping upstream (southeast) face of the dam.

Figure 12. AZ Q:13:27 (ASM), Feature 3, looking southeast at the buttresses on the downstream (northwest) face of the dam.

Figure 13. AZ Q:13:27 (ASM), Feature 3, looking east at the downstream (northwest) face of the dam.

Figure 14. AZ Q:13:27 (ASM), Feature 3, looking south at the downstream (northwest) face of the dam and the broken section.

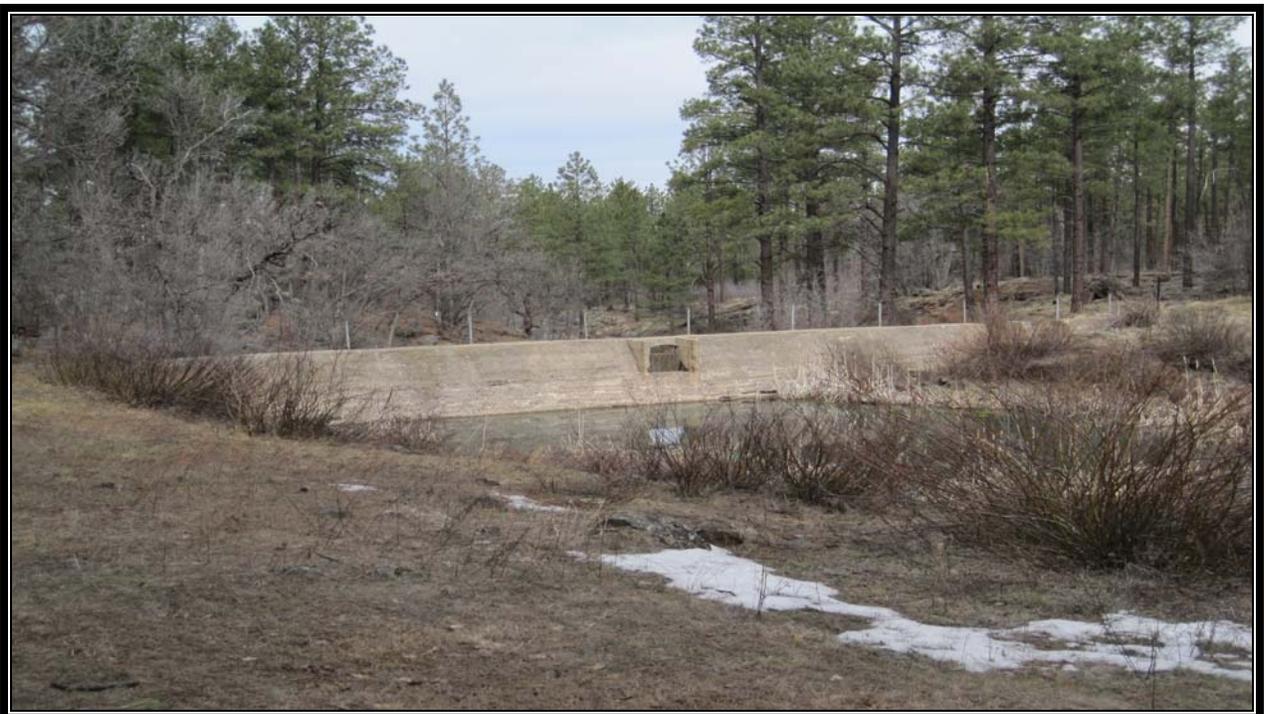
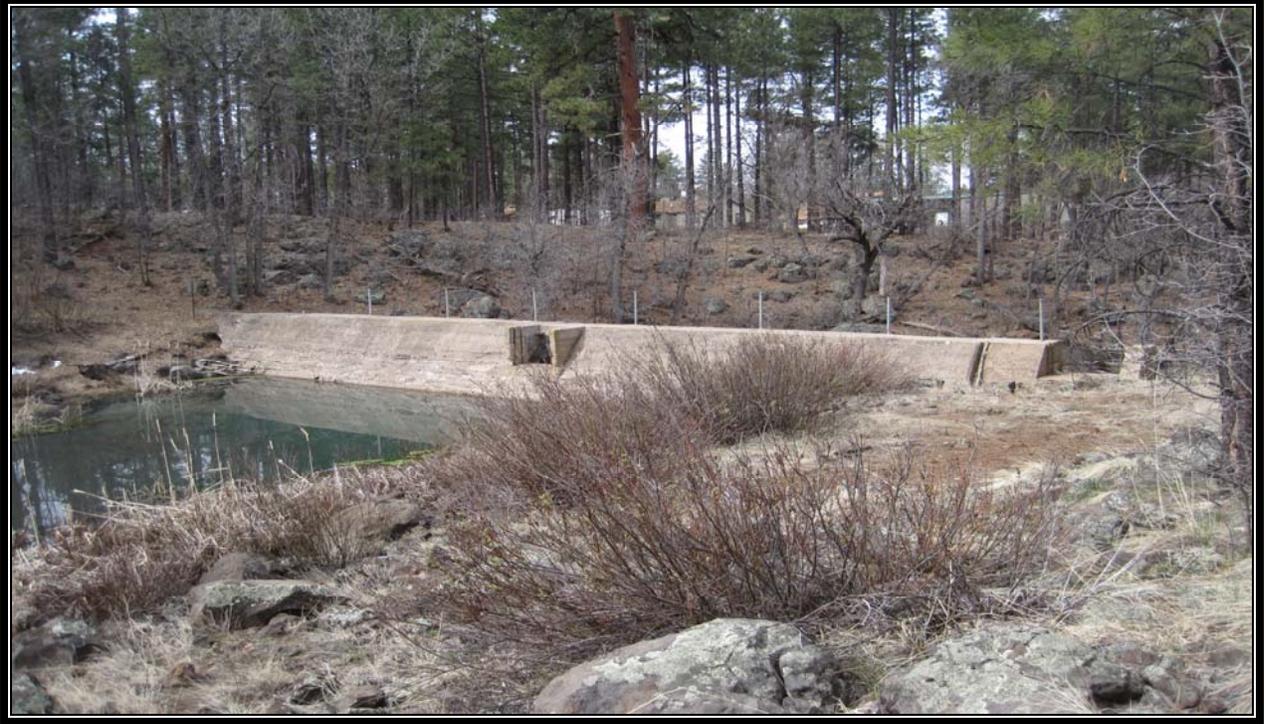
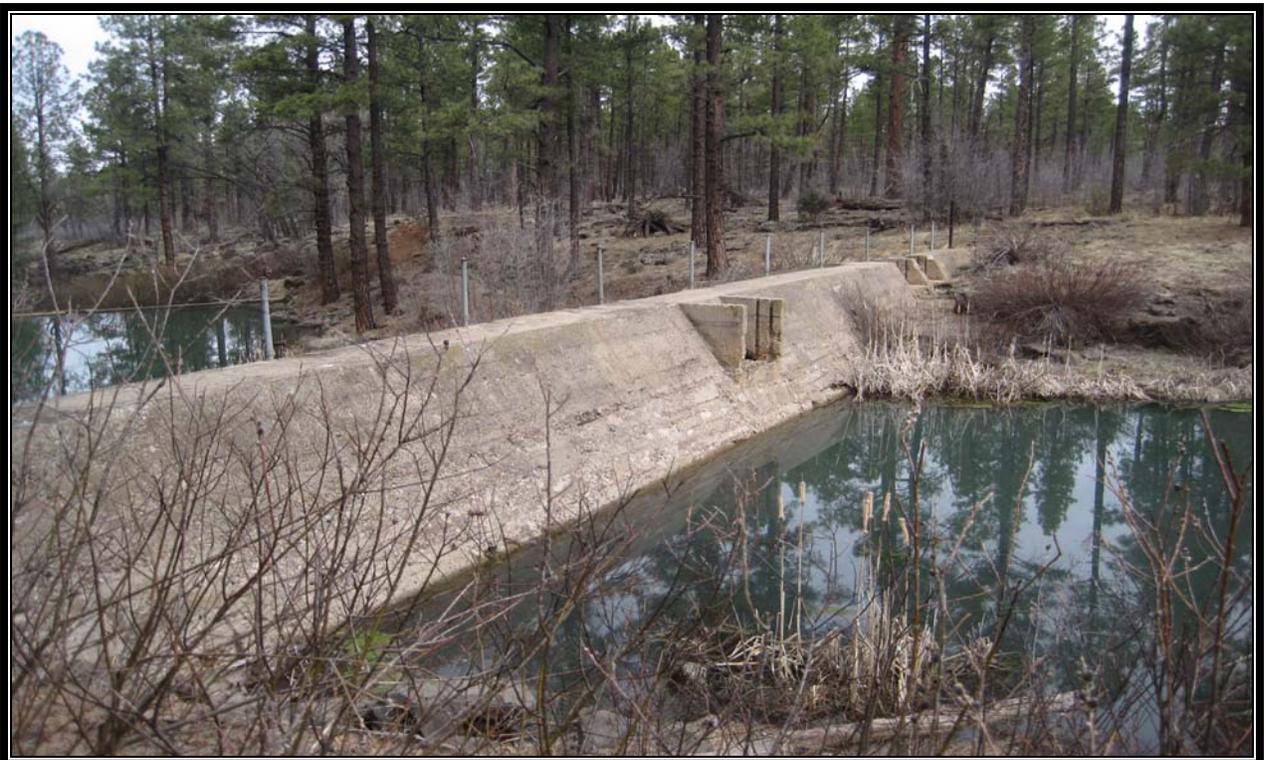
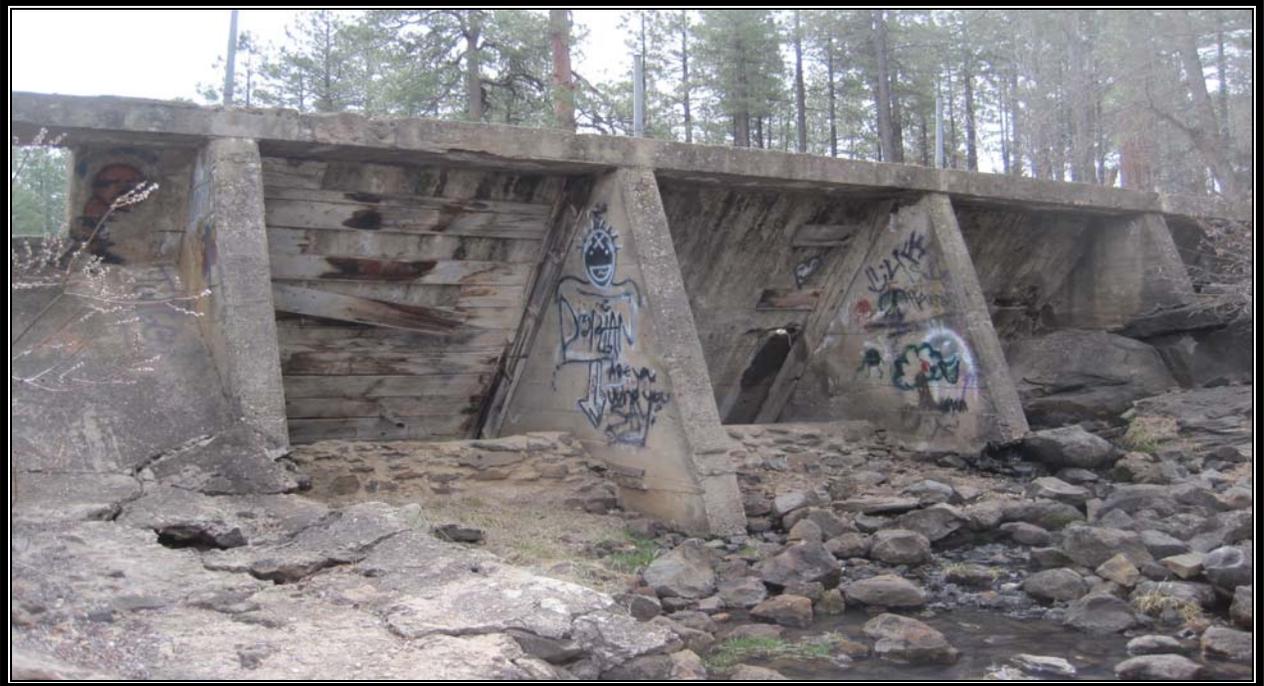
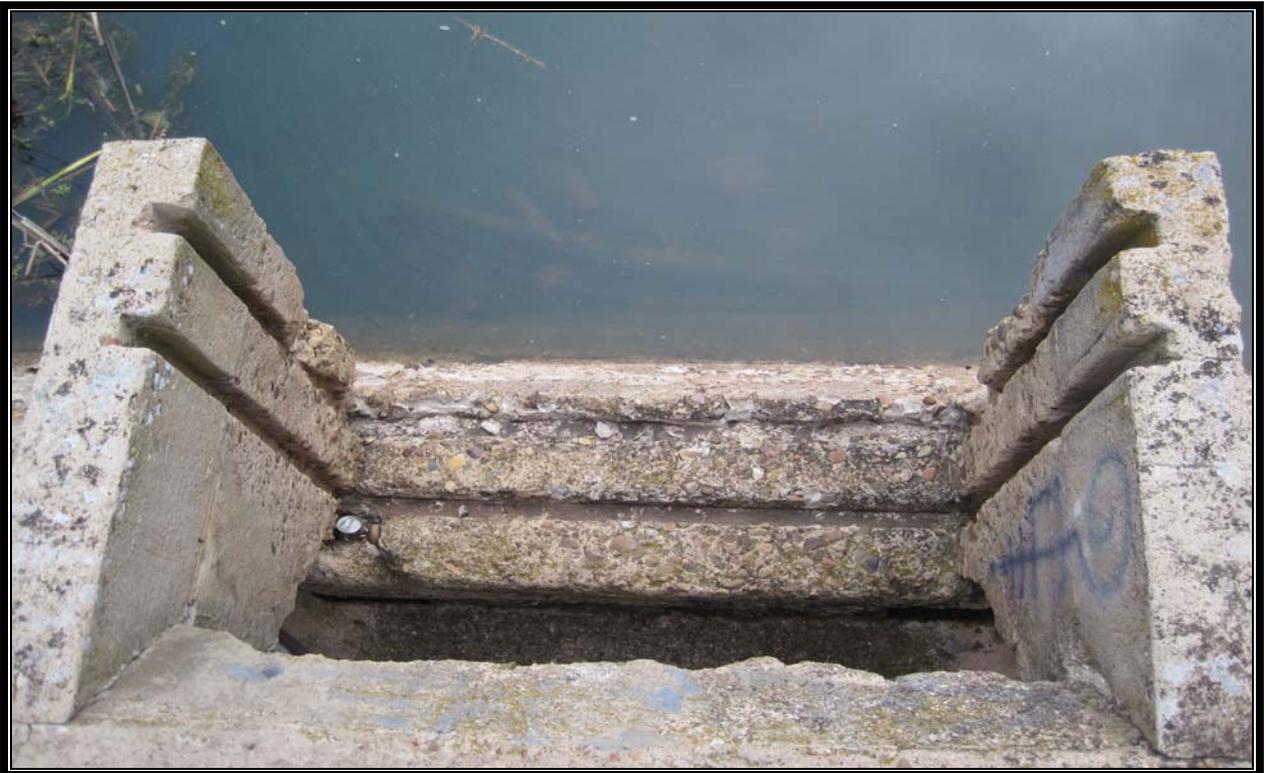
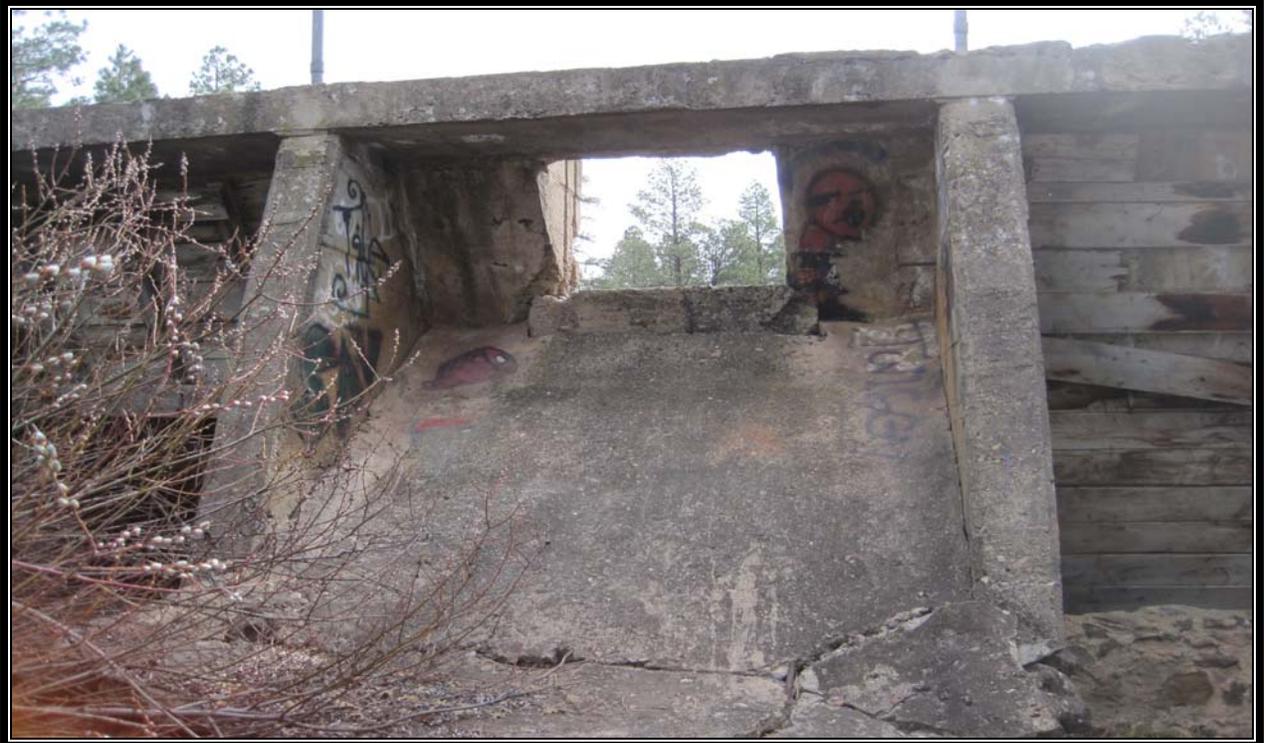
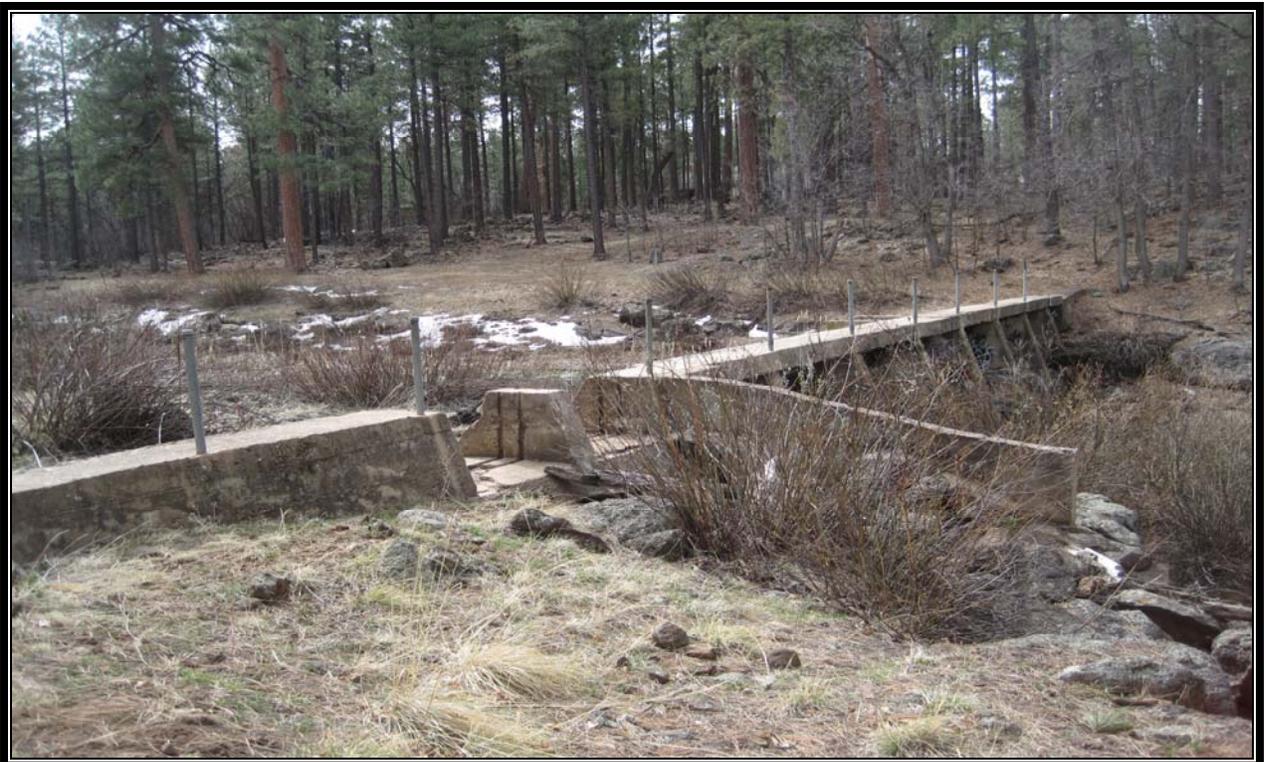
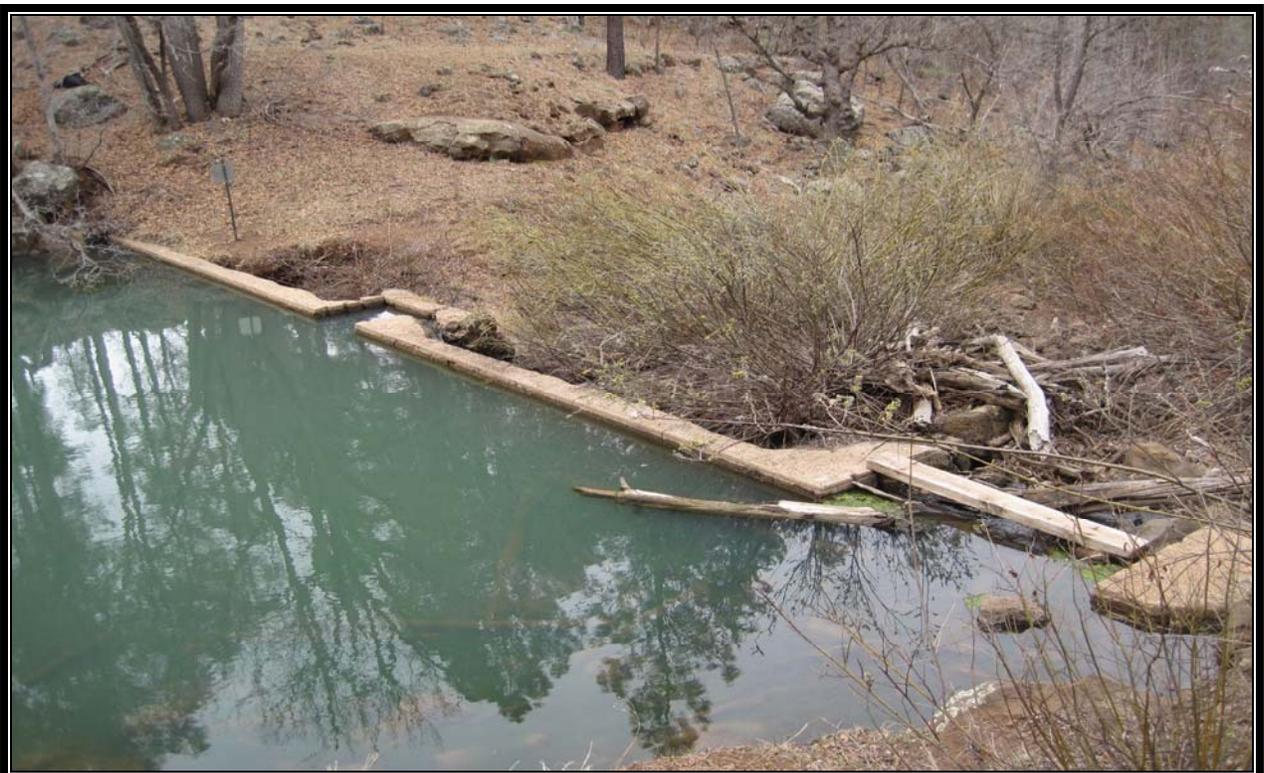
Two outlets or spillways are located on the dam (Figures 19-21). A box-like opening near the center of the upstream face and a partially broken concrete spillway on the opposite downstream side functioned as an outlet for water. Slots in the concrete indicate that a gate may have been present, although no other evidence of one was

Figure 15. AZ Q:13:27 (ASM), Feature 4, looking northwest at the upstream (southeast) face of the dam.

Figure 16. AZ Q:13:27 (ASM), Feature 4, looking west at the upstream (southeast) face of the dam.

Figure 17. AZ Q:13:27 (ASM), Feature 4, looking north at the sloping upstream (southeast) face of the dam.

Figure 18. AZ Q:13:27 (ASM), Feature 4, looking southeast at the buttresses on the downstream (northwest) face of the dam.

Figure 19. AZ Q:13:27 (ASM), Feature 4, looking downward at the outlet on the upstream (southeast) face of the dam.

Figure 20. AZ Q:13:27 (ASM), Feature 4, looking southeast at the spillway near the center of the downstream (northwest) face of the dam.

Figure 21. AZ Q:13:27 (ASM), Feature 4, looking south at the spillway near the northeast end of the dam.

observed. The opening is rectangular and is 4 ft. 11 in. parallel to the long axis of the dam, 3 ft. 1.5 in. perpendicular to the long axis, and 3 ft. 7 in. high.

Figure 23. AZ Q:13:27 (ASM), Feature 4, looking west showing the vertical upstream face, the center outlet, and the northeast spillway.

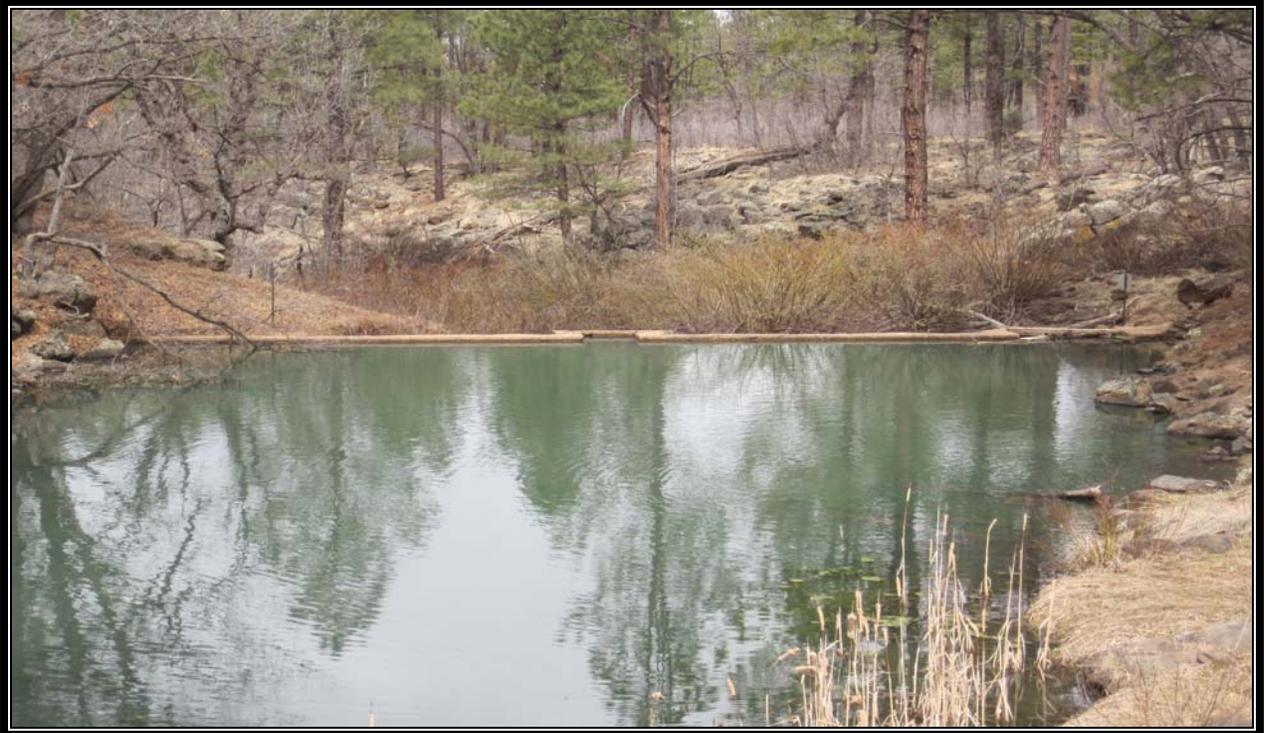
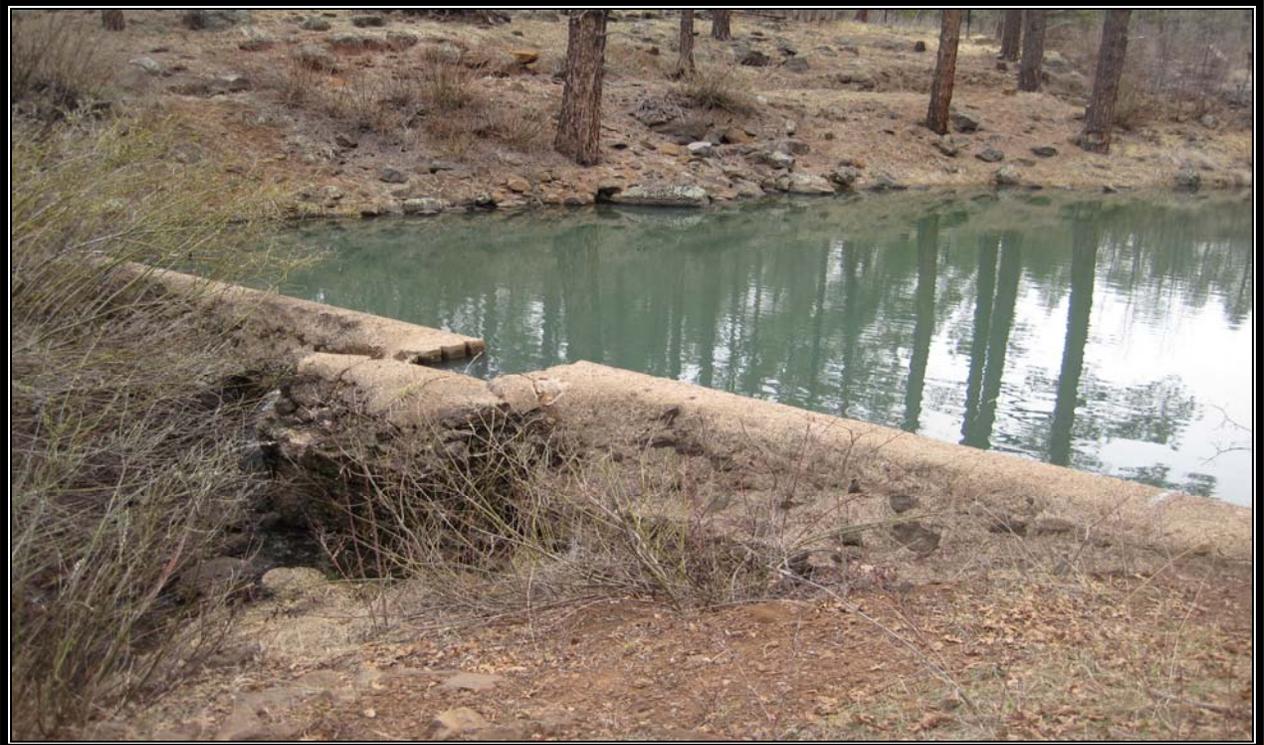
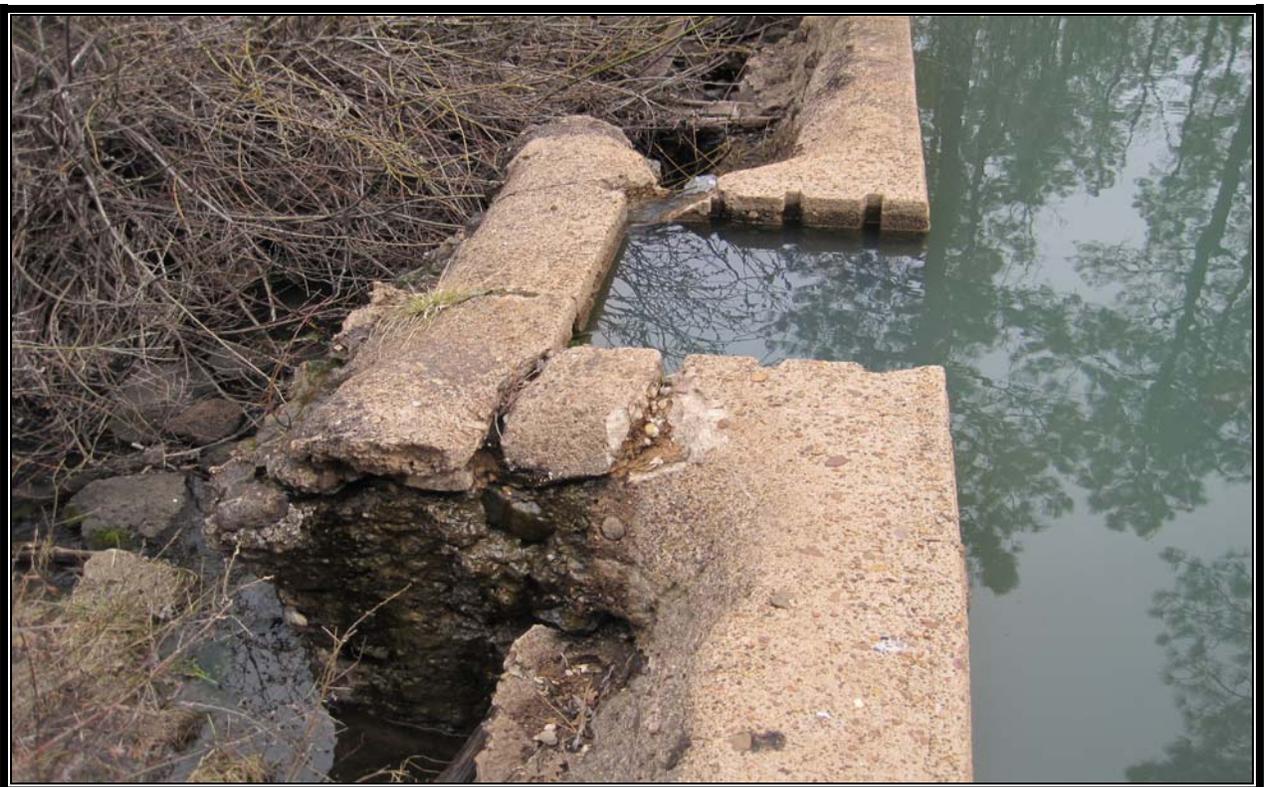
A rectangular, box-like opening is located near the center of the dam and currently allows water to flow through a broken section (Figure 25). Slots in the concrete along the opening suggest that it may have been used as a gate for regulating the flow of water through the dam, although no other evidence of a gate was observed. The opening measures 3 ft. 1 in. parallel to the dam and 2 ft. 8 in. perpendicular to it. A spillway is located near the northeast end of the dam, and measures 6 ft. 6 in. parallel to the dam and 4 ft. 8 in. perpendicular to it.

Figure 22. AZ Q:13:27 (ASM), Feature 5, looking northwest at the upstream (southeast) face of the dam.

Figure 24. AZ Q:13:27 (ASM), Feature 5, looking east at the downstream (northwest) face of the dam.

Figure 25. AZ Q:13:27 (ASM), Feature 5, looking northeast at the center outlet.

Feature 5 appears to have been constructed by cementing local rocks into place with concrete. The surfaces on the upstream and top of the dam have been smoothed or were possibly constructed with forms; the downstream surface is rough with exposed rock present. Overall, the construction is more rough-hewn than the Features 3 and 4, the other two concrete dams within AZ Q:13:27 (ASM). Feature 5 is in fair condition. It is mostly intact, although sections at the center outlet and northeast spillway are broken and allow water to flow through.
