Pinetop-Lakeside Aquatic Wildlife Enhancement Project

**Arizona Water Protection Fund Grant Application – FY 2019
Arizona Game and Fish Department; Pinetop Regional Office**

A Class III Archaeological Survey of the Arizona Game and Fish Department Pinetop Region Headquarters in Pinetop-Lakeside, Navajo County, Arizona

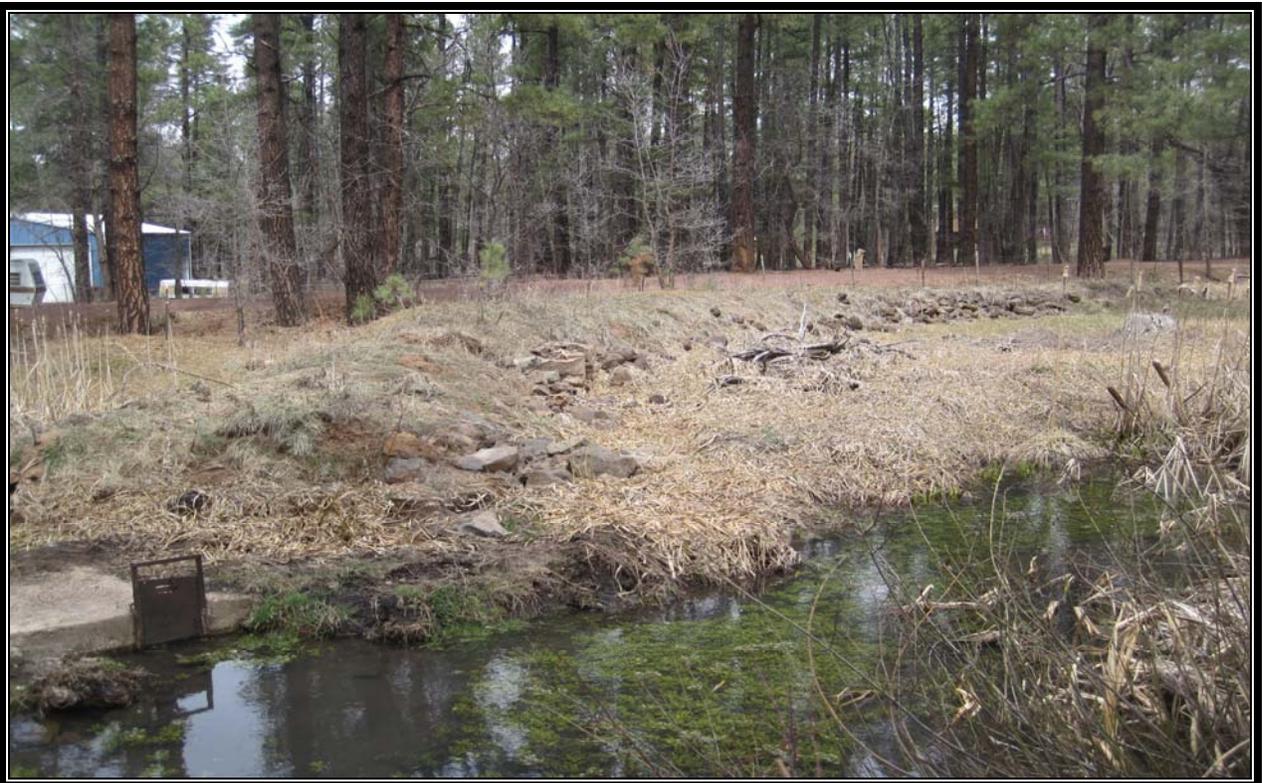
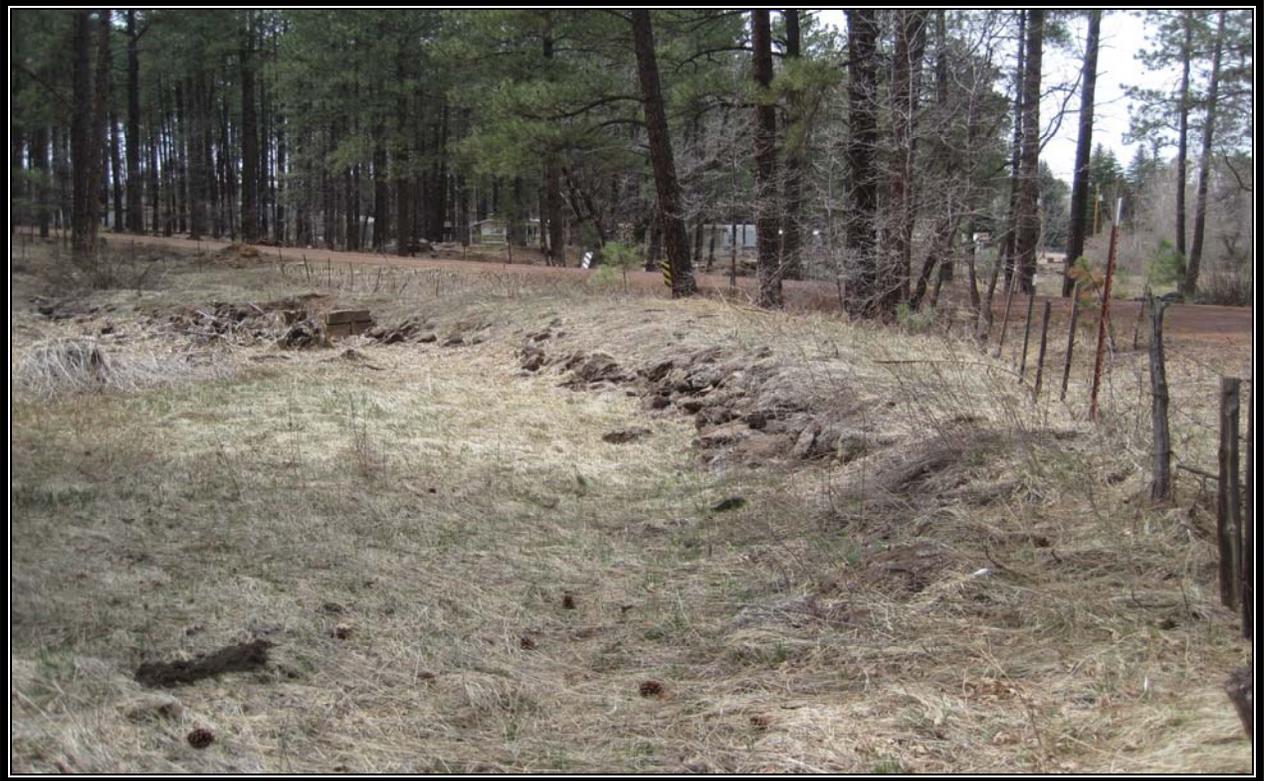
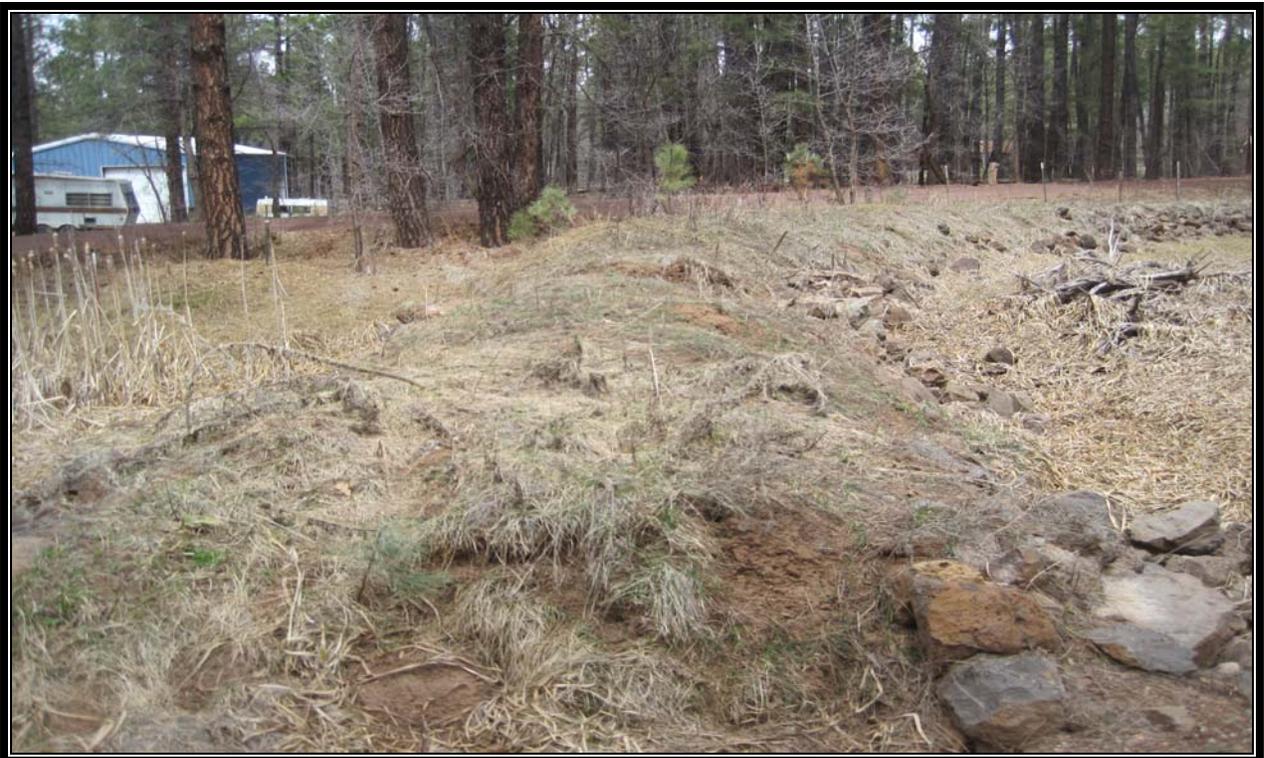
Feature 9: Feature 9 is a diversion dam made of rock and earth that is located in the northwest corner of the APE (Figures 33-35). The feature is curvilinear, arcing from southwest to northeast, with the concave portion to the southeast. Feature 9 is located in the general drainage of Billy Creek; however, the creek flows around the southwest end of the feature. It is 127.0 ft. long, 12-14 ft. wide at the base, and 3.0-4.0 ft. wide along the slightly rounded but generally level top. Feature 9 varies from 3.0-4.0 ft. high, with sloping sides.

Figure 33. AZ Q:13:27 (ASM), Feature 9, looking north.

Figure 34. AZ Q:13:27 (ASM), Feature 9, looking west.

Figure 35. AZ Q:13:27 (ASM), Feature 9, looking north.

Several pieces of broken concrete are present near the southwest end of the feature and may have been the remains of an opening, although no other evidence of such was found. A flat, level slab of concrete is located southwest of the southwest end of Feature 9. The slab has a functioning metal gate. It could not be determined if slab and gate were associated with Feature 9, or represent a separate feature.

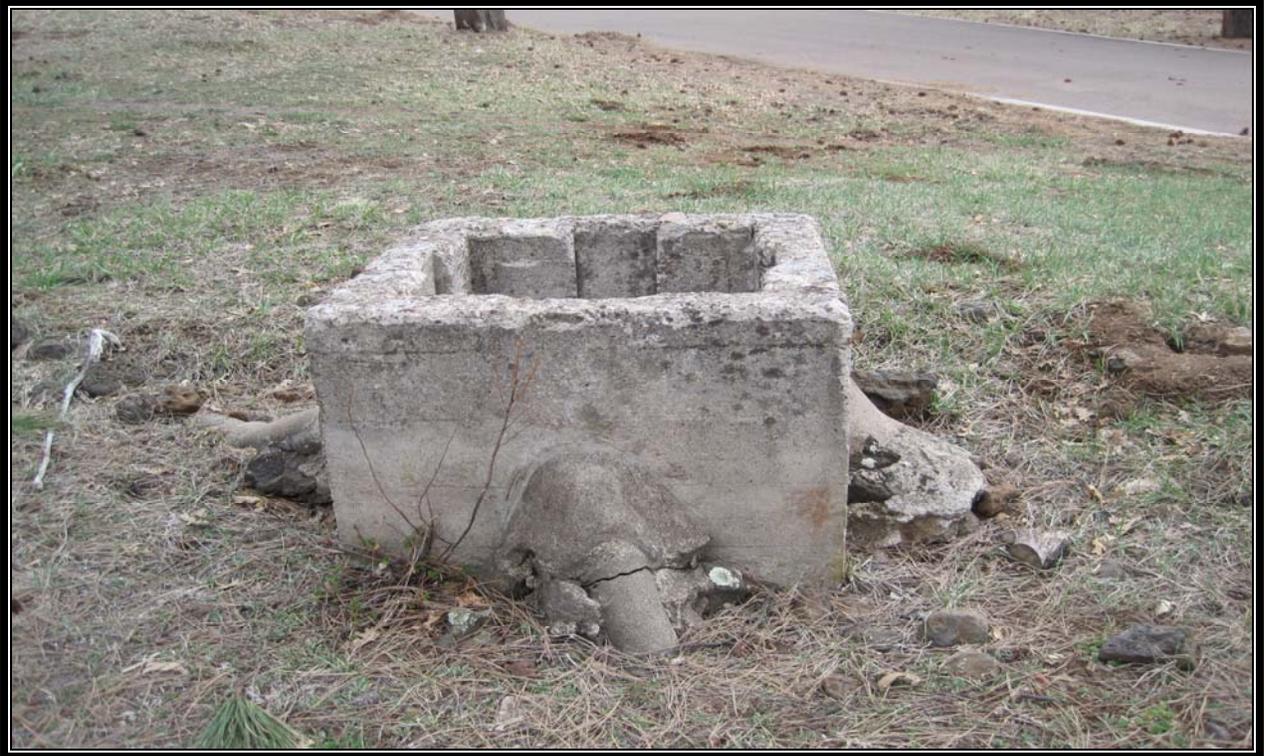
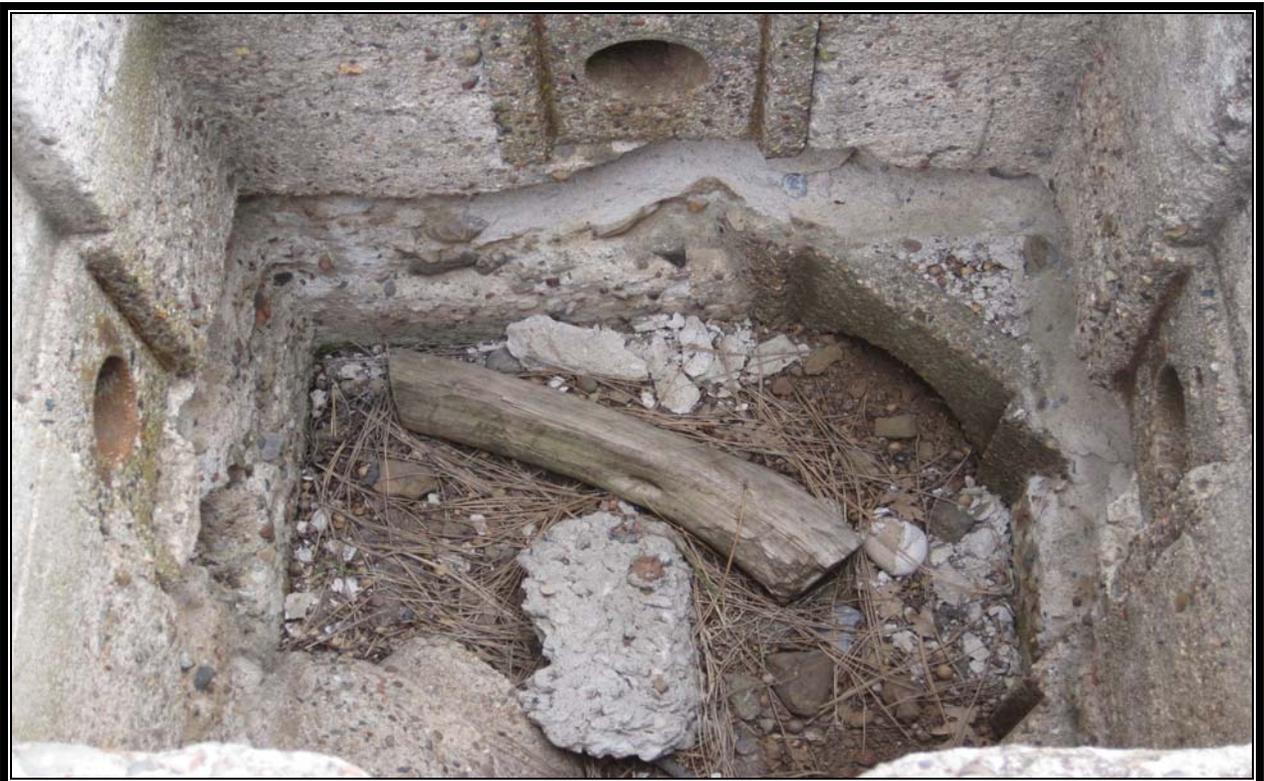
Feature 11: Feature 11 is a concrete water junction box that is located approximately 75 ft. southwest of Feature 10 (Figures 40-41). The feature is square, open on top, with inlets/outlets on all four sides and in three corners. It is constructed of formed concrete, and is 3 ft. 4 in. on each side. The exterior height is 2 ft. 4 in.; the interior measures 3 ft. 3 in. high. According to AGFD personnel, it was used to control the flow of water from the hatchery building into nearby basins. Feature 11 is in fair condition, with some broken concrete and weathered sections.

Figure 40. AZ Q:13:27 (ASM), Feature 11, looking east.

Figure 41. AZ Q:13:27 (ASM), Feature 11, looking downward into the junction box.

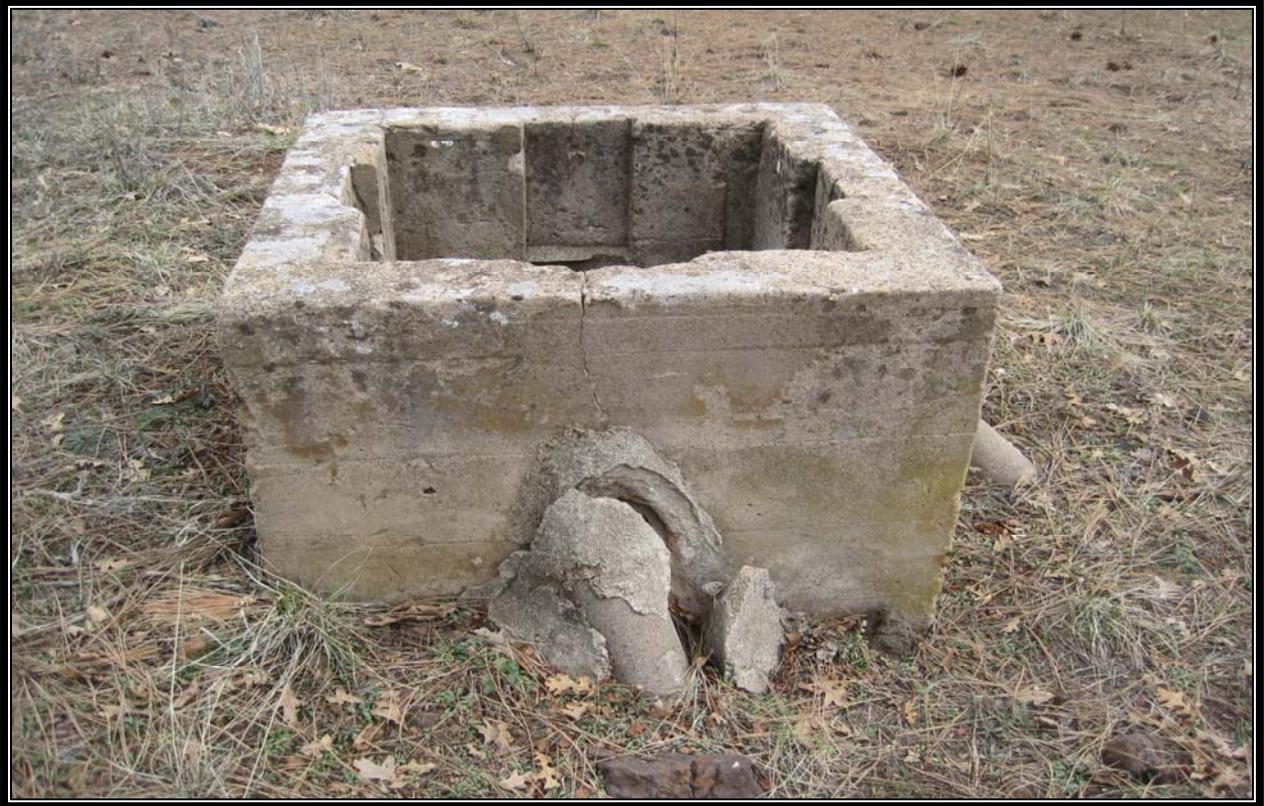
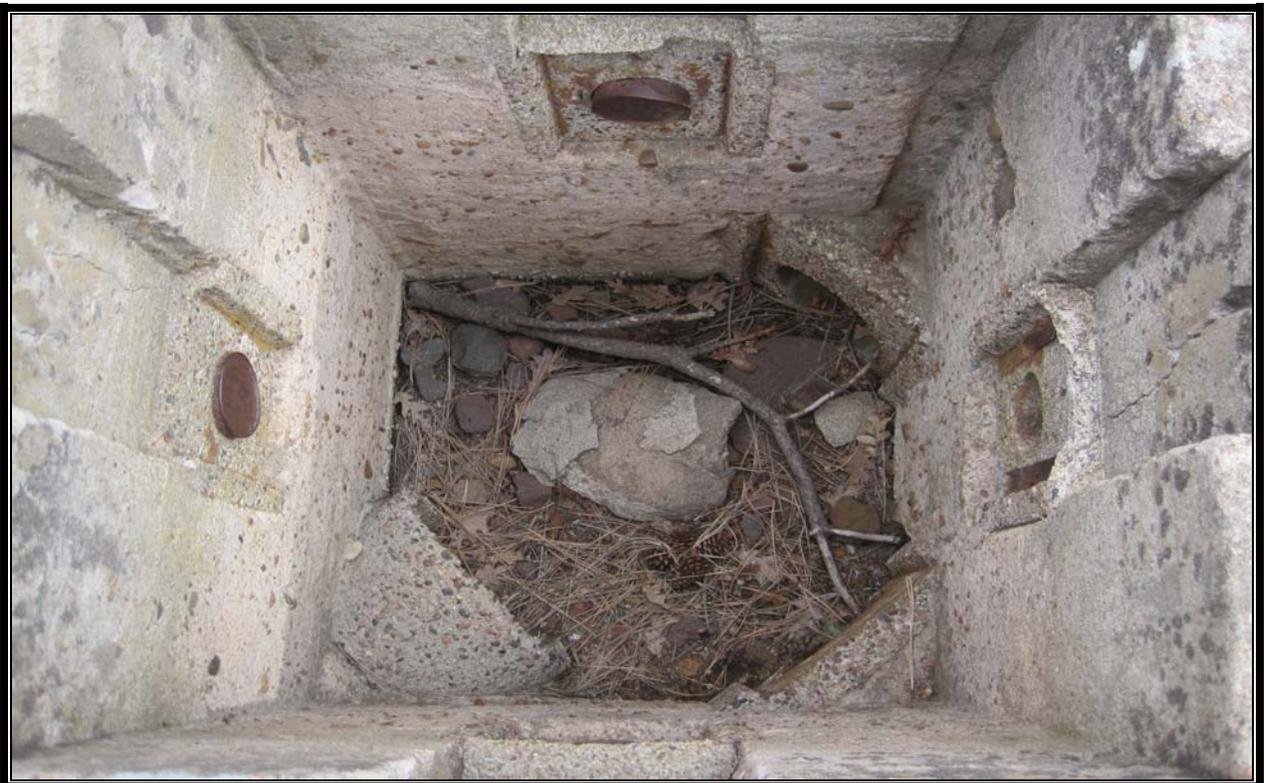
Feature 12: Feature 12 is a concrete water junction box, very similar to Feature 11, that is located approximately 40 ft. west of Feature 10 (Figures 42-43). The feature is square, open on top, with inlets/outlets on all four sides and in three corners. It is constructed of formed concrete, and is 3 ft. 4 in. on each side. The exterior height is 2 ft., 4 in. and the interior is 3 ft. 7 in. As with Feature 11, Feature 12 was apparently used to control the flow of water from the hatchery building into nearby basins. Feature 12 is in fair condition, with some broken concrete and weathered sections.

Figure 42. AZ Q:13:27 (ASM), Feature 12, looking southeast.

Figure 43. AZ Q:13:27 (ASM), Feature 12, looking downward into the junction box.

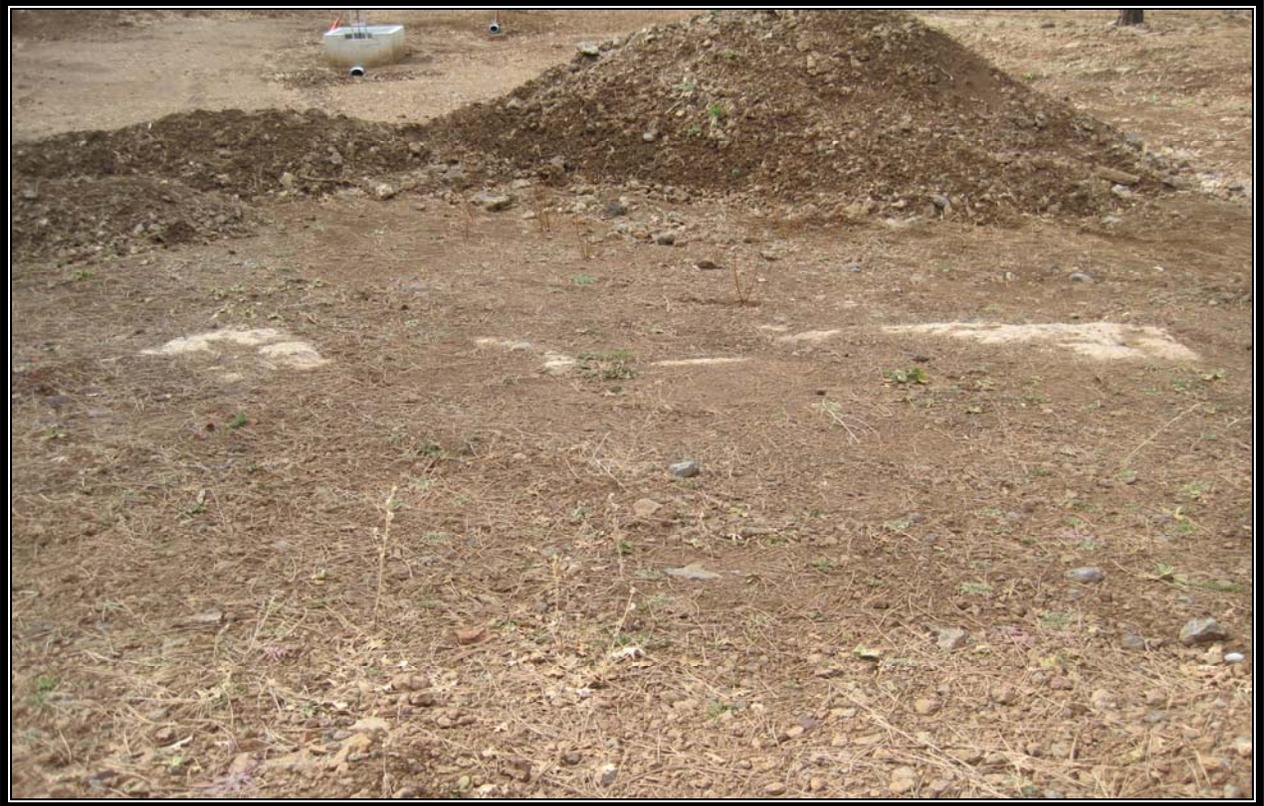
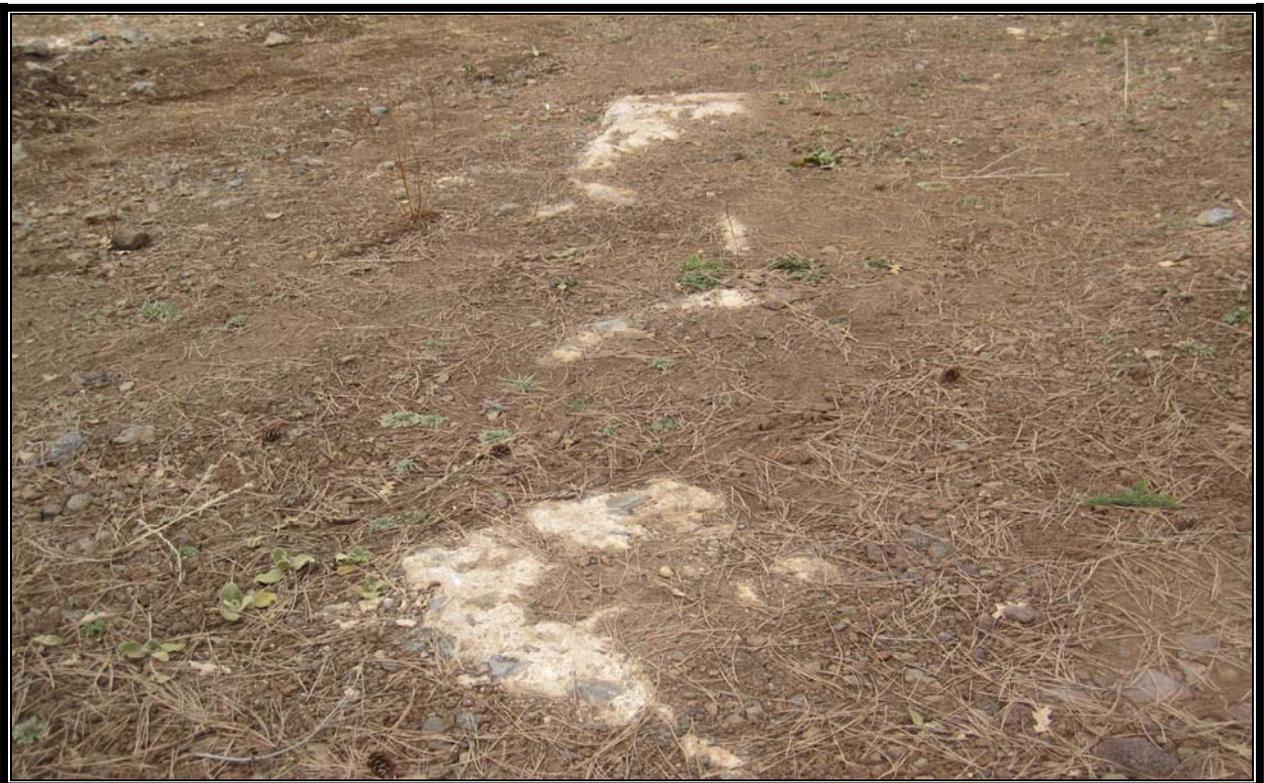
Figure 44. AZ Q:13:27 (ASM), Feature 13, looking northwest.

Figure 45. AZ Q:13:27 (ASM), Feature 13, looking north.

- The proposed wetland will cover Feature 13 (a portion of a concrete reservoir base),
- Construction of a water junction box within an existing junction box adjacent to Feature 10 (fish hatchery building), and
- Repair leaks to Feature 16 (water pipeline).

Although Feature 13 will be covered by the proposed wetland, it will not be destroyed and will be preserved by the wetland. As such, this is not considered an adverse effect to AZ Q:13:27 (ASM). The existing water junction box adjacent to Feature 10 was constructed at a later date than the original building, and is not considered a contributing feature to the hatchery building. As such, construction of a water junction box within the existing box is not considered an adverse effect to the hatchery building or to the site. Repair and maintenance of existing waterlines are considered permissible activities under Arizona State Historic Preservation Office guidelines; therefore work on

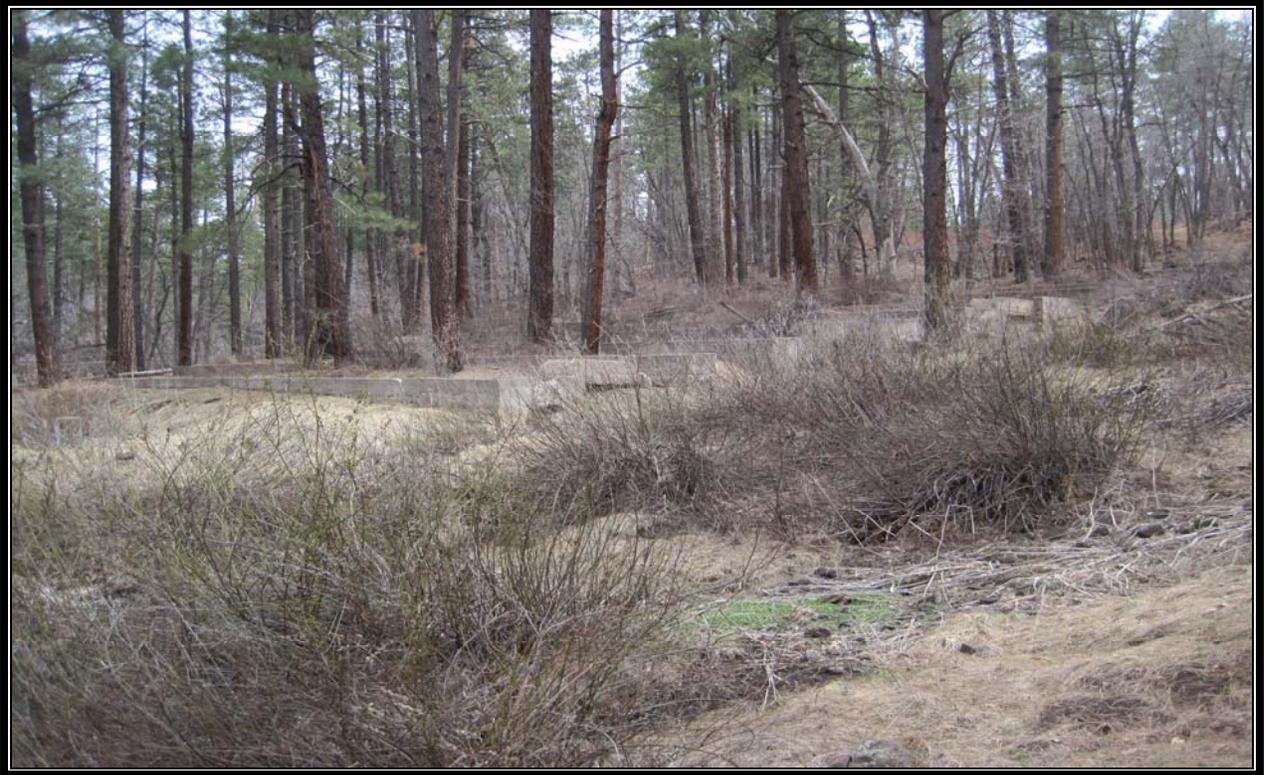
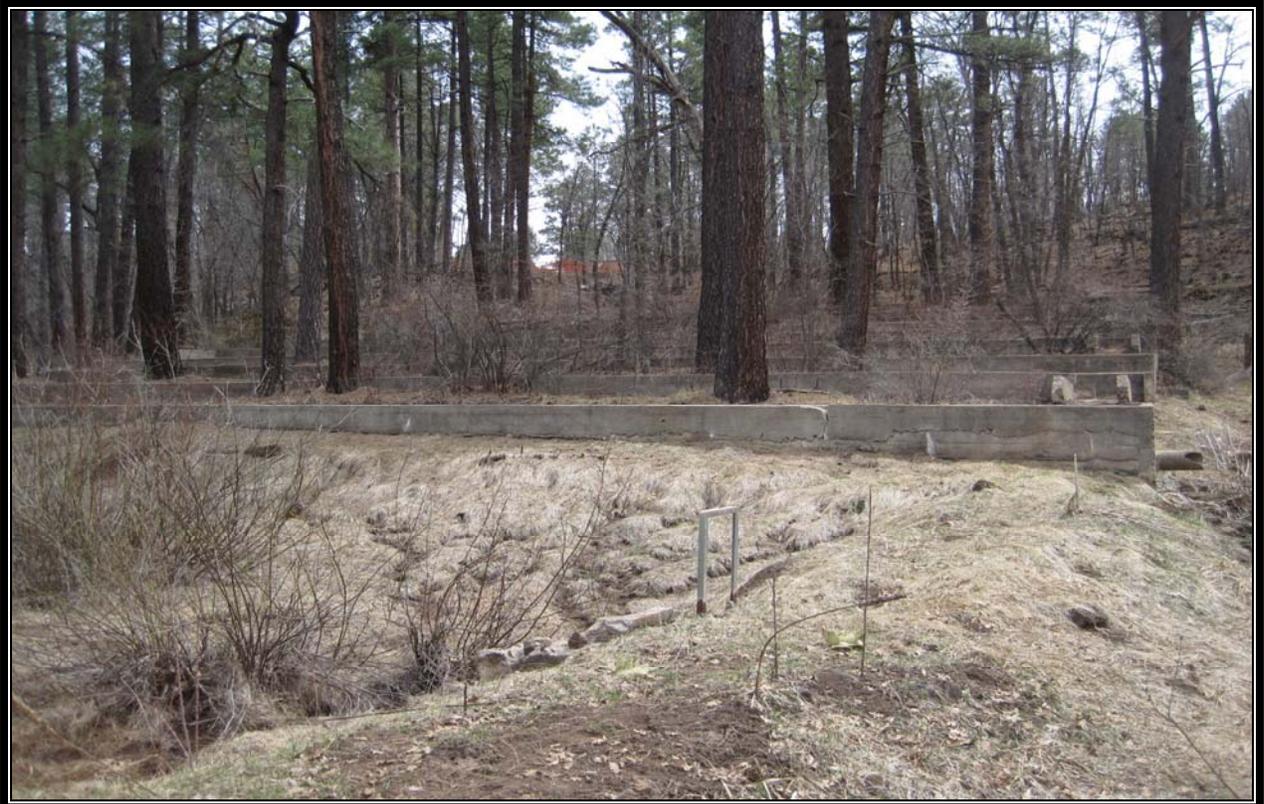
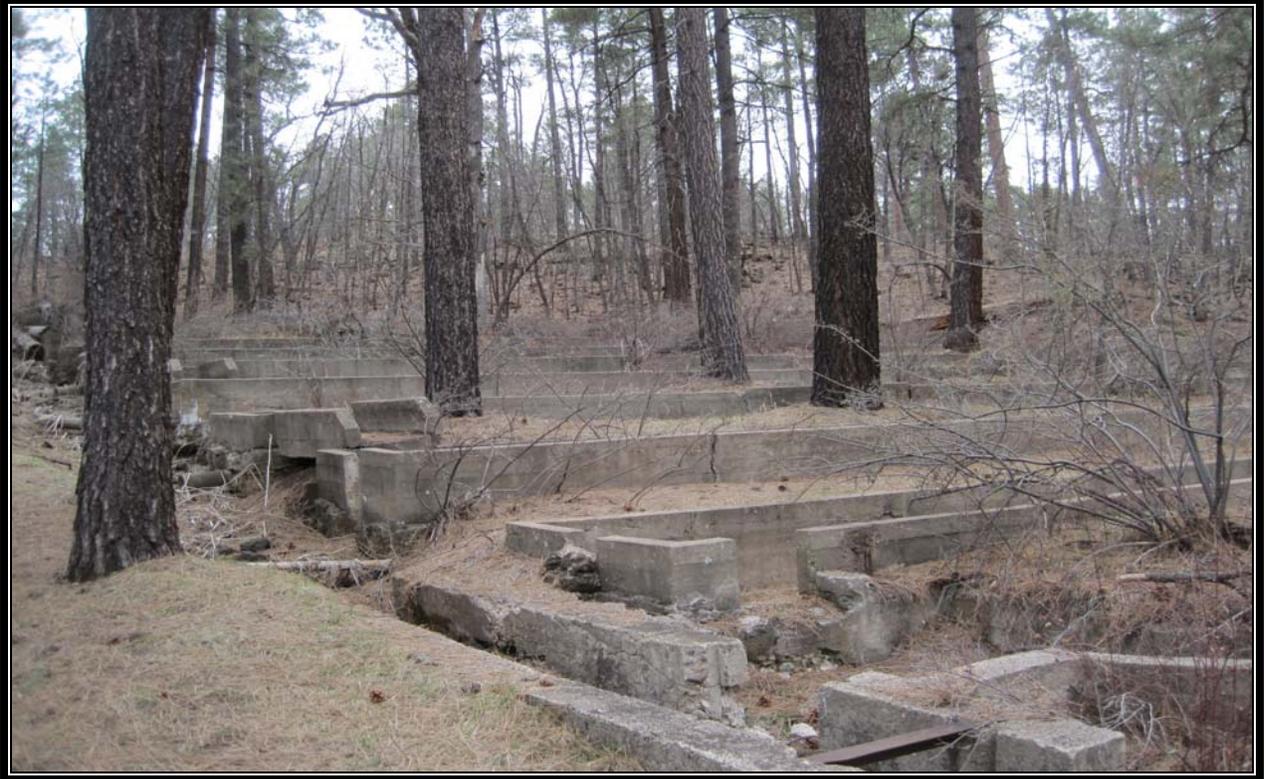
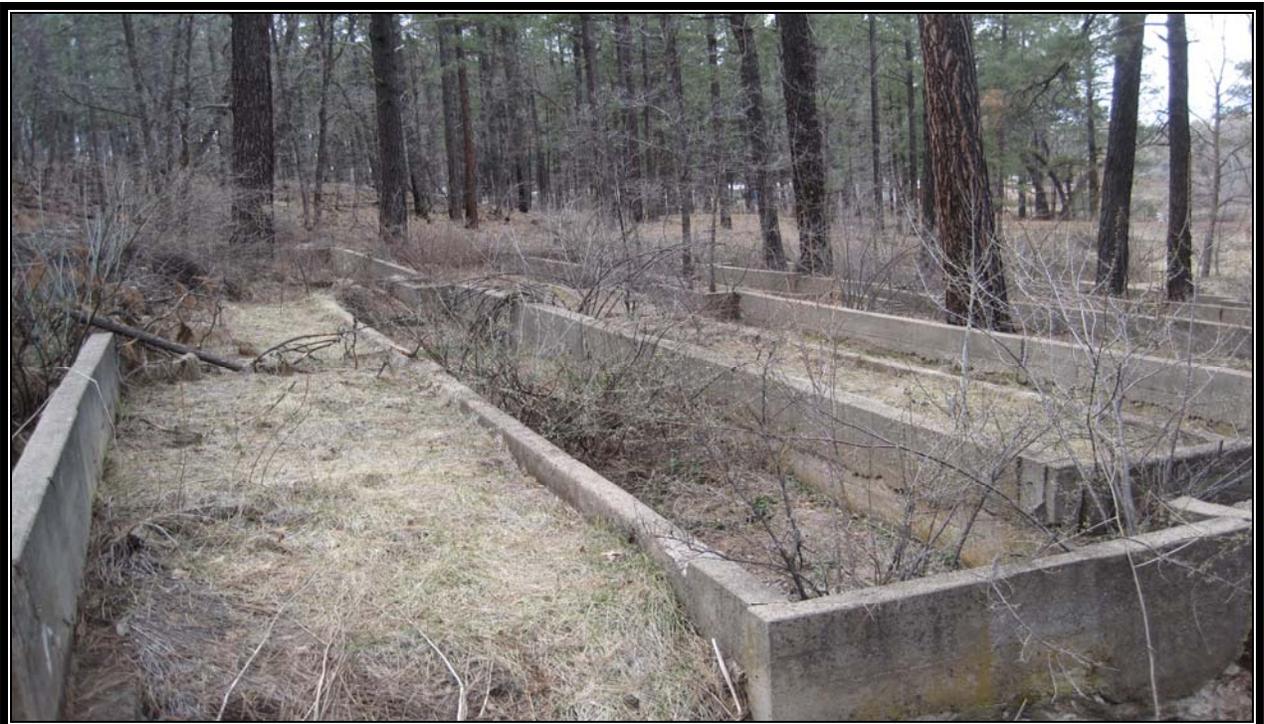
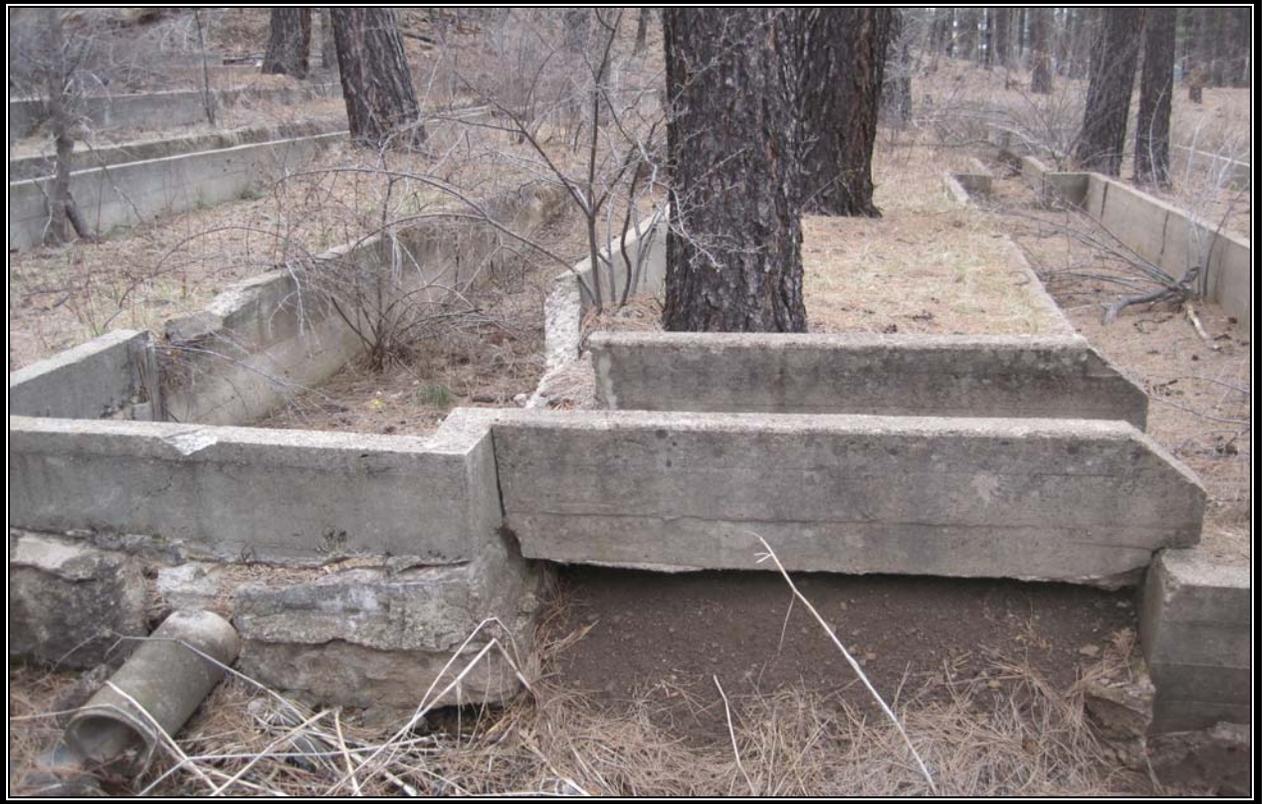
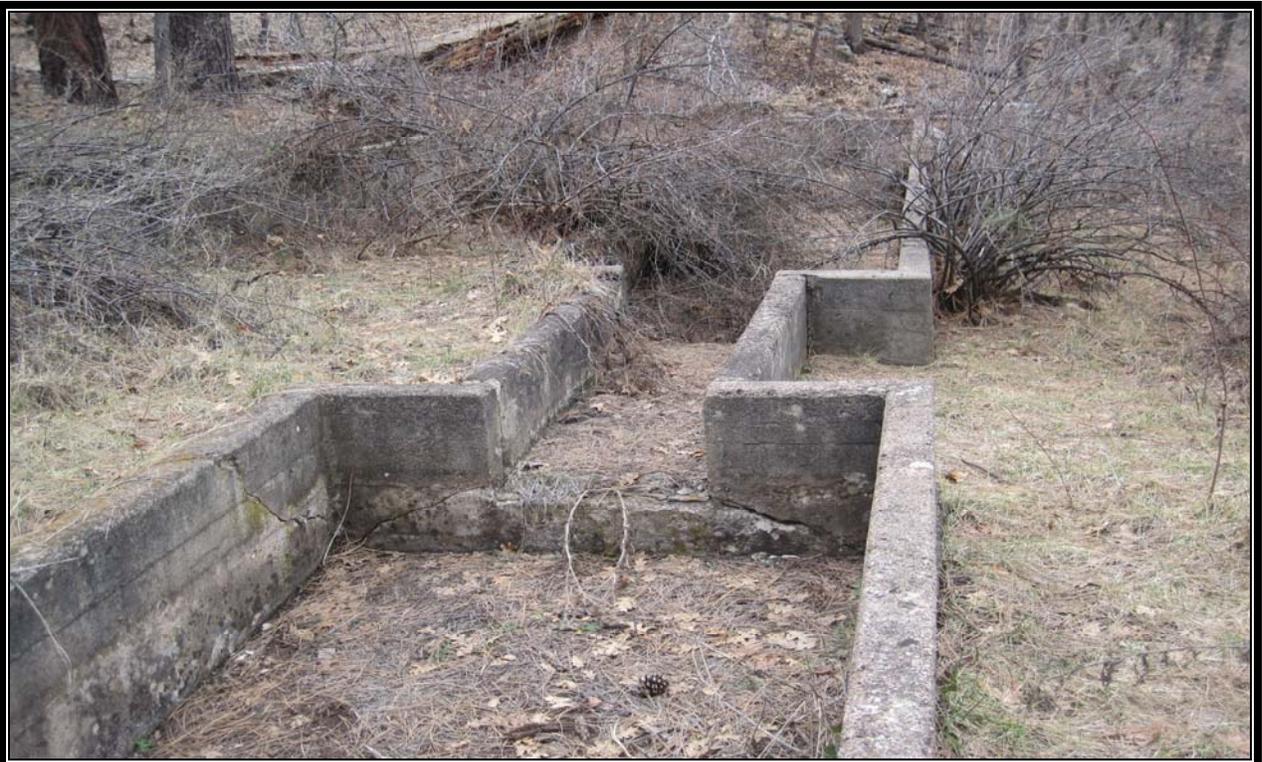
The raceway is 92.0 ft. from the top to the bottom (northwest-southeast) and 86.0 ft. wide (northeast-southwest). The troughs are also 86.0 ft. long, 5.5 ft. wide, and have an average depth of 2 ft. 4 in., although debris in the bottom prevented consistent measurements. The raceway is constructed of poured and framed concrete. It is in fairly good condition and is mostly intact, although there are numerous broken sections

Figure 46. AZ Q:13:27 (ASM), Feature 14, looking southeast at the raceway.

Figure 47. AZ Q:13:27 (ASM), Feature 14, looking southeast at the raceway.

Figure 48. AZ Q:13:27 (ASM), Feature 14, looking south at the raceway.

Figure 49. AZ Q:13:27 (ASM), Feature 14, looking northwest at the raceway.

Figure 50. AZ Q:13:27 (ASM), Feature 14, looking west at the raceway.

Figure 51. AZ Q:13:27 (ASM), Feature 14, looking west at a typical constriction.

and holes throughout and sediment and debris in the troughs. Ponderosa pine trees up to two ft. in diameter are located within the raceway.

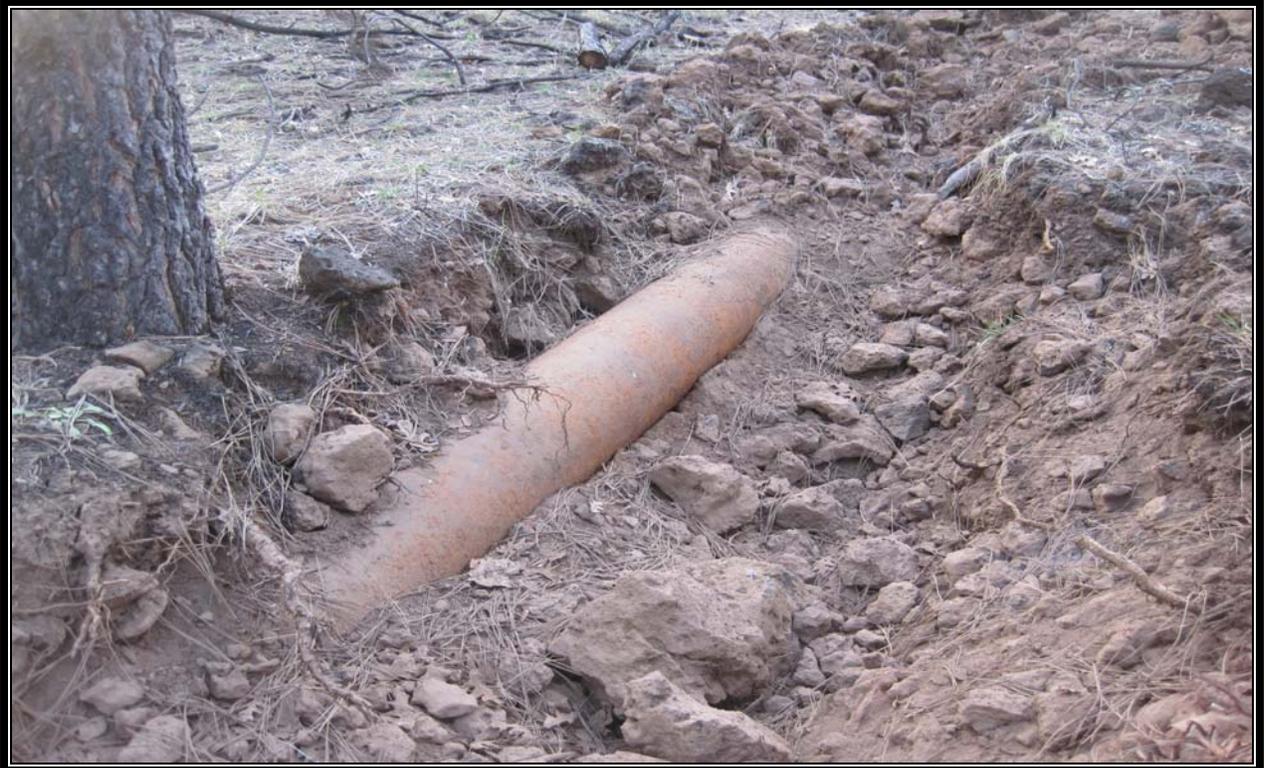
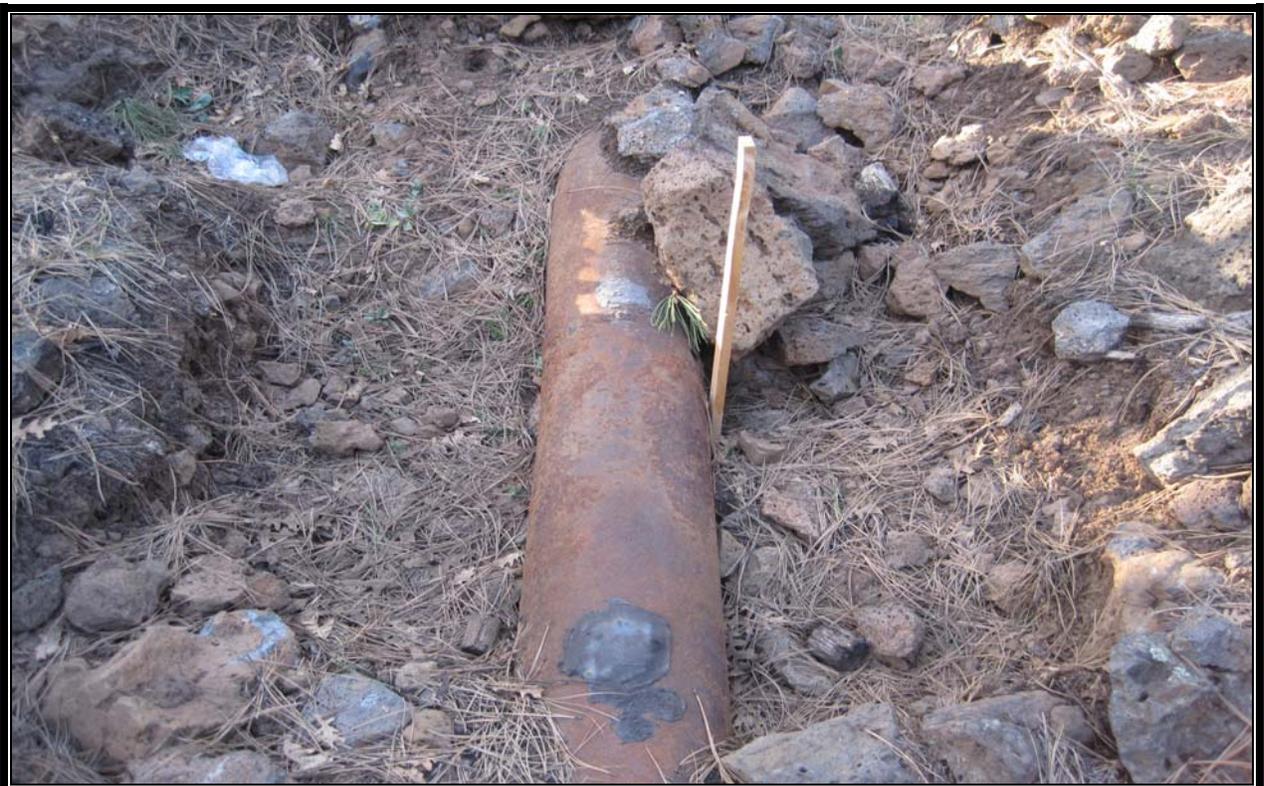
The pipe is located beneath the ground, and could not be observed with the exception of two areas in the southeast portion of the APE at which modern excavations had been done to expose and repair the pipe. The two areas are approximately 50 ft. apart, and

Figure 54. AZ Q:13:27 (ASM), Feature 16, looking southeast at the exposed waterline.

Figure 55. AZ Q:13:27 (ASM), Feature 16, looking southeast at the exposed waterline.

expose 3.0-5.0 ft. of pipe in each location. Based on these areas, the water line consists of a 1.0 ft. diameter metal pipe that is buried approximately 0.5-1.0 ft. below the modern ground surface. It is in poor condition, very rusted with numerous holes and patched sections observed. The age of the water line could not be determined; however, the condition of the pipe and discussions with AGFD personnel suggest that this may be the original line to supply the hatchery.
